FRIENDS OF BRANDY BOTTOM COLLIERY, PUCKLECHURCH

Newsletter N^o 18, February 2018

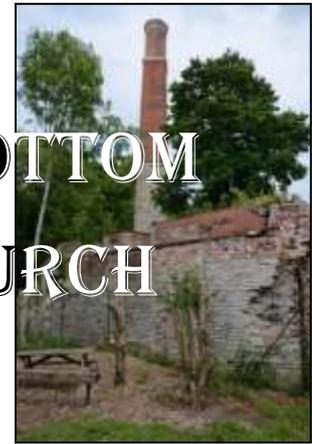
The 2 work parties in December 2017 brought the total for the year to 56, one more than in 2016, while there have been 3 so far in 2018. Contract masons have almost finished working on the walls of the New Pit heapstead, the Horizontal Engine House and the Cornish Engine House. As a result almost all the initial major stabilisation work on the site, apart from the area around the fan housing has been completed. But that still leaves the volunteers many other things to do, such as repointing large expanses of exposed brick or masonry walls and the intention is to finish that during 2018.

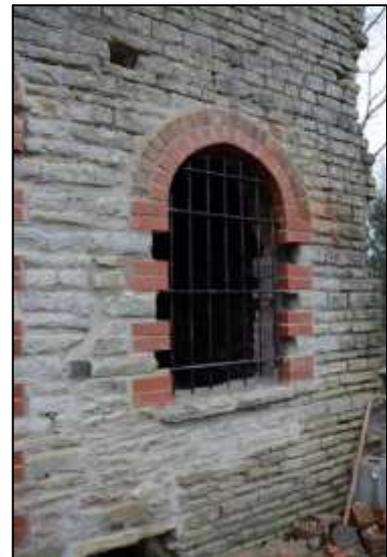
The rebuild of the tops of the eastern corner and south-east wall of the New Pit heapstead has been completed. The masonry of the walls forming the northern corner of the heapstead was in a very poor condition and had to be extensively patched. Photo 5 shows the corner, and photo 6 part of the north-west wall, while still covered by vegetation, while photos 7 to 9 show the same areas after the vegetation was removed but before work started. It was found that the vegetation had fortunately prevented a large vertical slice of wall between the corner and the northern-most tippler slot from collapsing. Photo 11 is a view of the rebuilt face of the northern corner and 17 shows the corner from a different angle. At the same time the tippler slots in the north-west wall were reconstructed. This was a much longer task than on the Old Pit, as the New Pit slots were found to

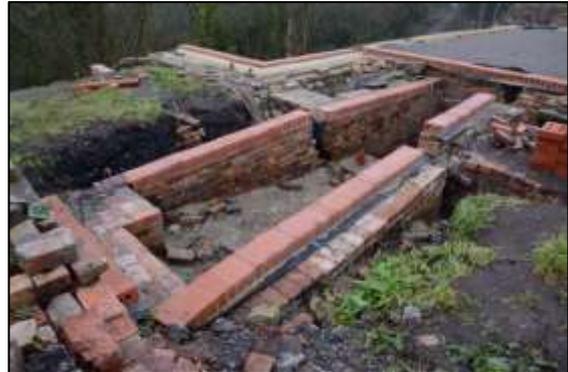
be in a poor state of preservation. Photo 12, taken in March 2017, shows just how bad things were, while photo 13, taken in January 2018, shows the same area after the rebuild. The slots were rebuilt using the ones on the Old Pit as a pattern. Photos 14 and 15 are 'before' and 'after' views of the northern tipler slot, while photos 16 and 17 show the rebuilt slots and heapstead walls. The walls of the winding ramp have also been rebuilt. Photo 18 shows the winding ramp area in January 2017, when a test trench had been dug between it and the south-east wall of the heapstead. Photo 19 shows the area in April after the walls were fully exposed. The photo on the right shows the rebuilt ramp walls from the south, while photo 20 is another view from the opposite side.

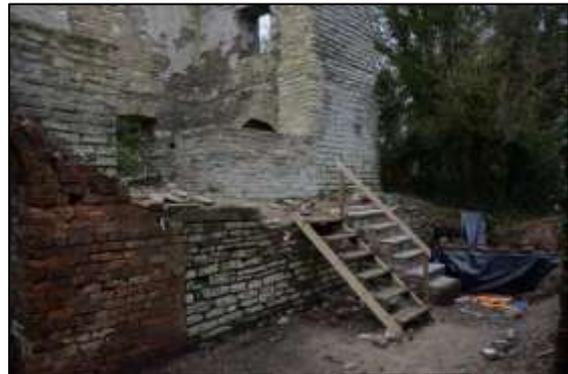
The undercroft of the Horizontal Engine House was surveyed in early December, and a number of photos taken of various areas. The photo on the right (© H Orr-Ewing, 2017) shows the miners' font in the northern corner of the undercroft. There are two brick walls running almost the full length of the undercroft that would have been used to support the machinery, and photos 26 to 28 were taken

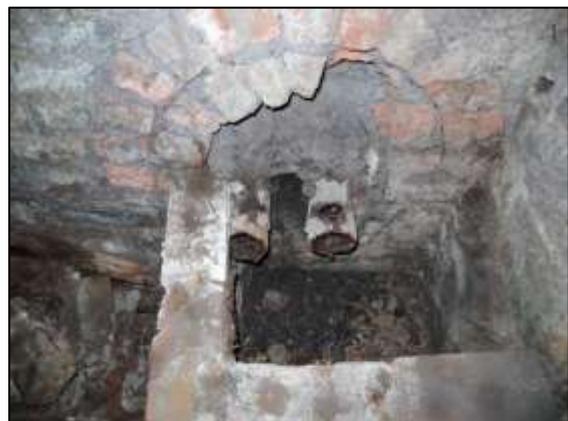
along the space between them. The rusty shuttering used in casting the floor can be seen at the top of photo 26. The floor appears to have been cast on the top of the brick walls, and it is not clear at present whether the engine settings have been destroyed. There are bricks heaped up in places (photo 27) and it is not obvious where they came from. A number of bull-nosed bricks were salvaged from the heaps, and have been used in the rebuild of the eastern corner of the engine house (photo 31). This, for some strange reason, is the only corner of the building where they are used.

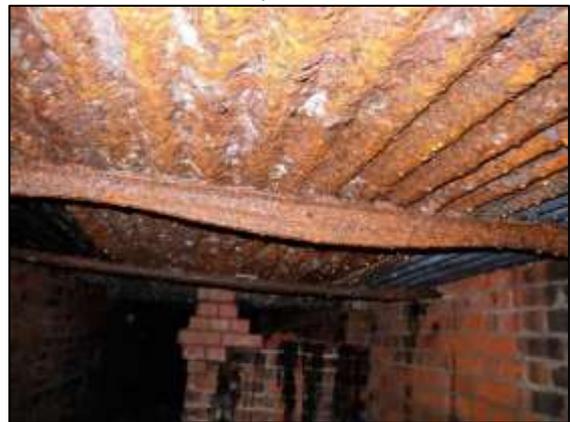
Photo 26 – View south-westwards under the floor of the Horizontal Engine House along the space between the two brick pedestals. The rusty corrugated iron at the top of the photo is the shuttering used when the modern concrete floor was cast. (© H Orr-Ewing, 2017)

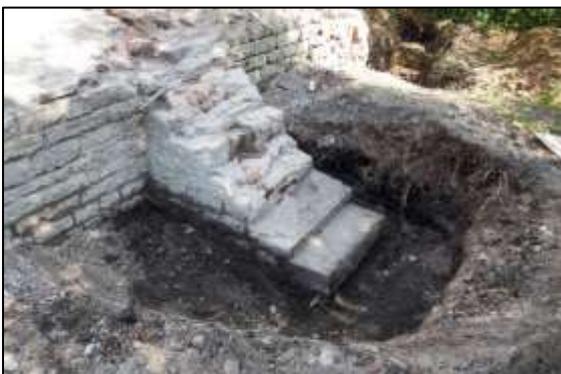
Photo 24 – The steps outside the south-west wall of the Cornish Engine House in June 2017 ...
