FRIENDS OF BRANDY BOTTOM COLLIERY, PUCKLECHURCH

Newsletter N° 7, May 2015

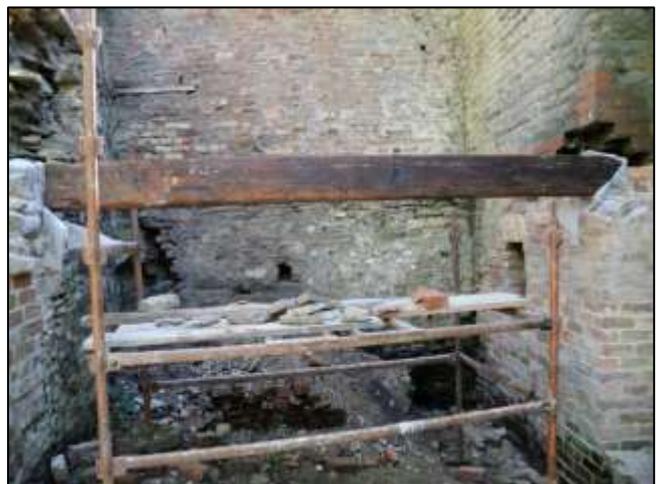
Work continued in the Old Boiler House, and the bracing beam (photo on right) was installed in April. The beam buttresses the north-east wall (on the left) against the heapstead (on the right), and will help to strengthen the wall against the pressure from the waste material in the batch. The beam has been bricked into the base of the chimney, completing the rebuild of that area. Photo 9 shows the beam being manhandled into place, while photo 10 is a view of the finished base of the chimney.

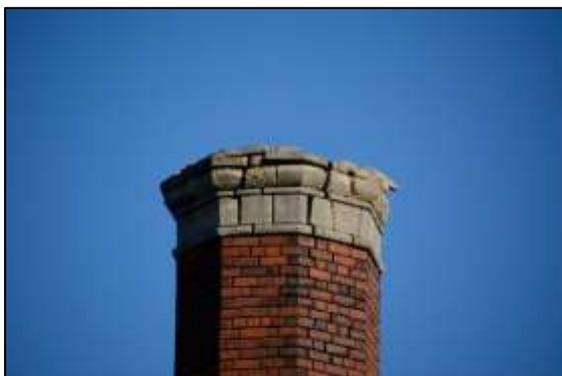
Photo 1 – The top of the chimney in January 2014 before any work started...

CWS Landscaping returned at the end of February, and repointed the stonework on the outside of the top of the chimney. This was paid for by a grant from Historic England, as the relevant part of English Heritage is now known. The photo on the right was taken when they had almost finished. Photos 1-3 shows how work has progressed over time, taken from near the storage container. Photos 4-8, which were

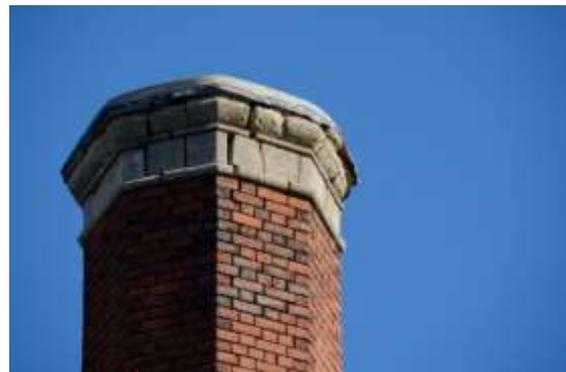
Photo 2 – ...the top with the reinforcing concrete ring in place in February 2015, but before repointing started...

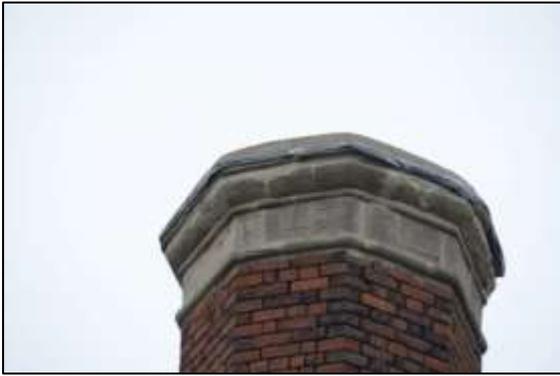
taken by the mason, C Skelton, in November 2014, show various stages in the rebuilding of the top and the casting of the concrete reinforcing ring. As is always the case with Brandy Bottom, another job surfaces as soon as one is finished. The pointing of the brickwork at the top of the chimney appeared to be in good condition when viewed from the ground. That was not found to be the case on closer inspection, and the top 6 feet will have to be repointed at a later date.

Photo 3 – ...and the top in March 2015 once the masonry section had been repointed.

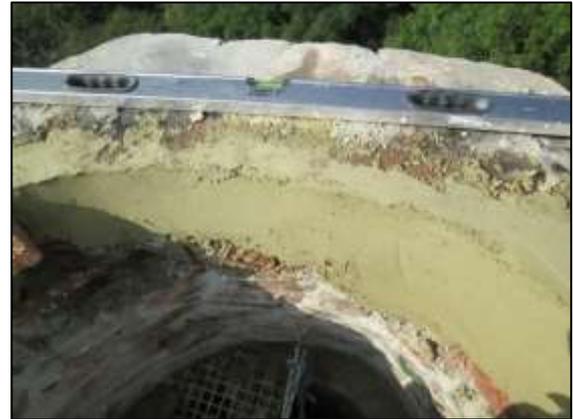
Photo 6 – Making the foundations for the cast concrete ring. © C Skelton, 2014.

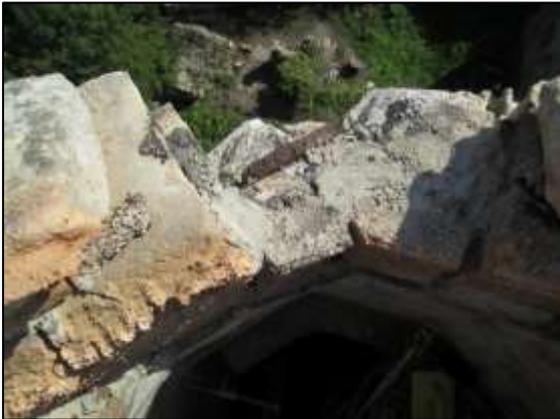
Photo 4 – Top of the chimney in the early stages of the work, with the Vertical Engine House at the top of the picture. © C Skelton 2014.

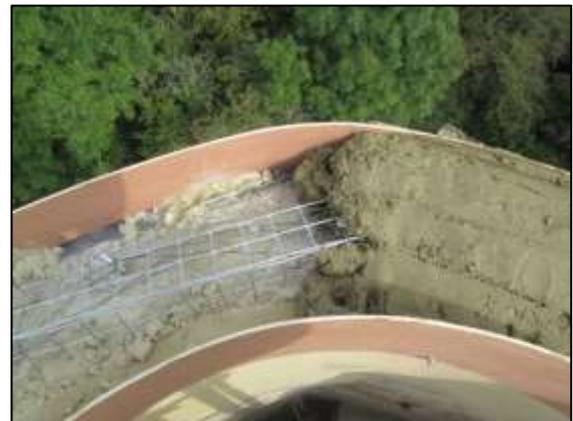
Photo 7 – Casting the concrete ring in situ. © C Skelton, 2014.

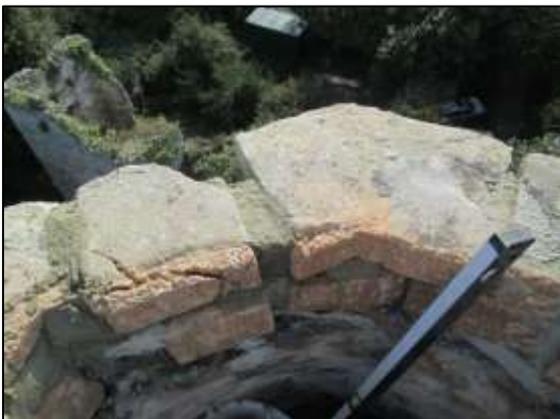
Photo 5 – Rebuilding the top of the chimney. © C Skelton, 2014.

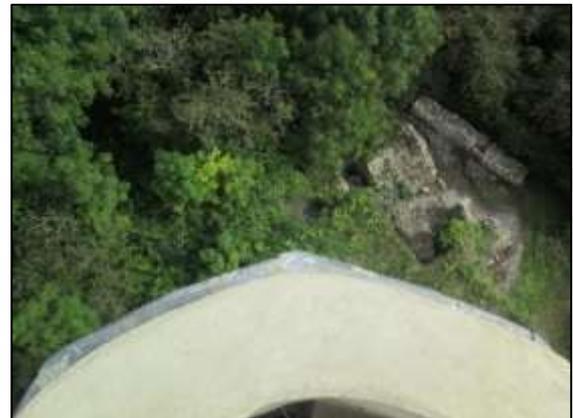
Photo 8 – Finished ring from above, with the lead flashing just visible on the outside edge and the Vertical Engine House towards the top right corner. © C Skelton, 2014.

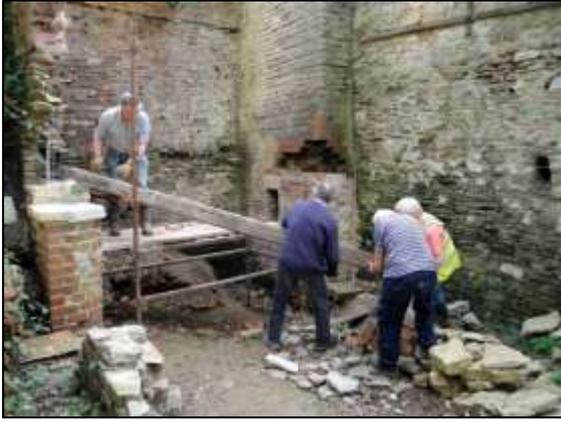
Photo 9 – Manhandling the bracing beam into place in the Old Boiler House.

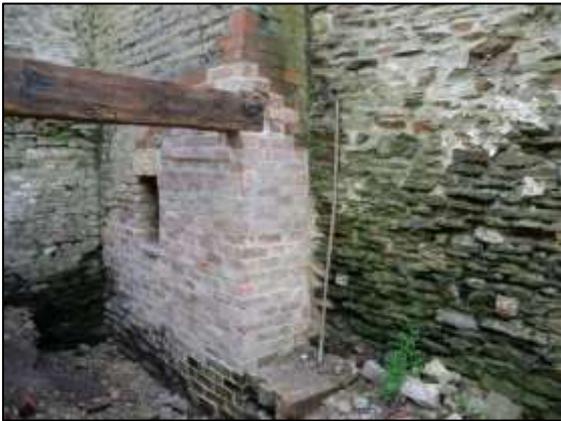
Photo 10 – The finished rebuild of the base of the chimney, with the bracing beam in place.

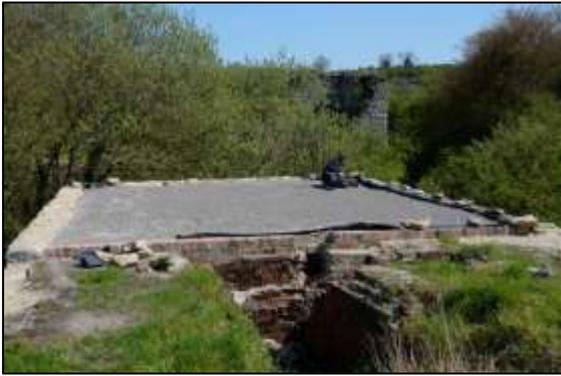
The excess waterproof membrane on the roof of the Horizontal Engine House has been removed. Photo 21 was taken as this was being done. The areas around the corner drains have still to be finished.

Photo 21 – Trimming the excess waterproof membrane on the roof of the Horizontal Engine House.
