Friends of Brandy Bottom Colliery Pucklechurch

Progress: May - August 2019

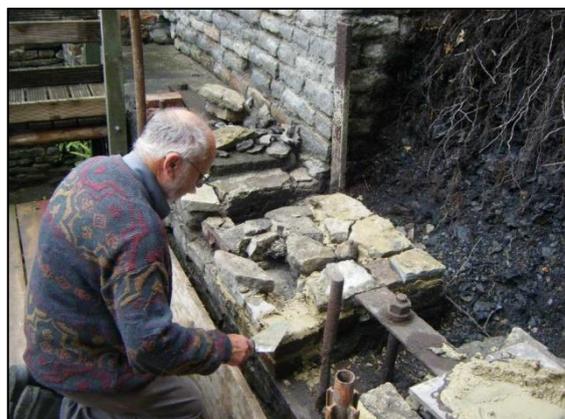
Repair work started on the top of the north-west wall of the winding drum pit in the Vertical Engine House in June, and Ken finished the job by the end of that month (photo right). The outside of the wall

was found to be in a better condition than the inside, probably because of the protection given by the

covering spoil. The scaffolding that has sat in the winding drum pit for months has now been dismantled.

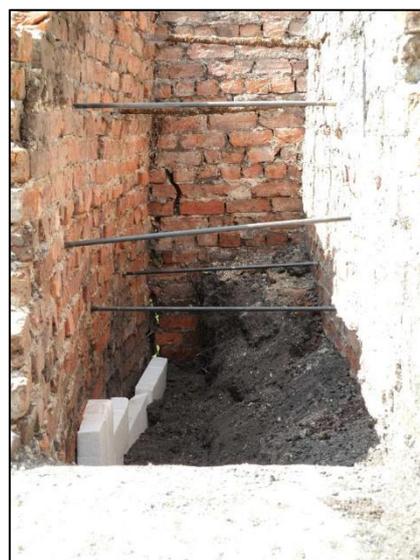
More spoil was excavated from behind the bulging brick wall at the south-west end of the Old Pit heapstead, and a second Acrow prop was fitted. Hamish and Jeff inserted four tie rods (photo [11](#)) with spreader plates through the outer wall and grouted them into anchorages in the inner wall. Spreader plates were also fitted to the two original tie rods after they were refurbished, and all the nuts tightened. This had the immediate effect of reducing the bulge in the wall, enough to make the second Acrow prop redundant before the end of that work party. A fifth tie rod was added mid-July. The nuts are being tightened a little at a time at each work party, slowly stabilising the wall. We appear to have acted in time before the wall collapsed or before it had deteriorated so far that it had to be completely rebuilt. Expanded polystyrene is being used as a low weight filler in the space behind the wall, which will reduce the outward pressure on the wall. The remaining space will eventually be backfilled with spoil and covered with a waterproof membrane. The photo on the right is a view of the area behind the wall, taken in mid-July, and showing the tie rods and some of the polystyrene in place. The outward curve of the wall on the left can be seen, and daylight can be seen through the crack running up the corner between the left hand and back walls.

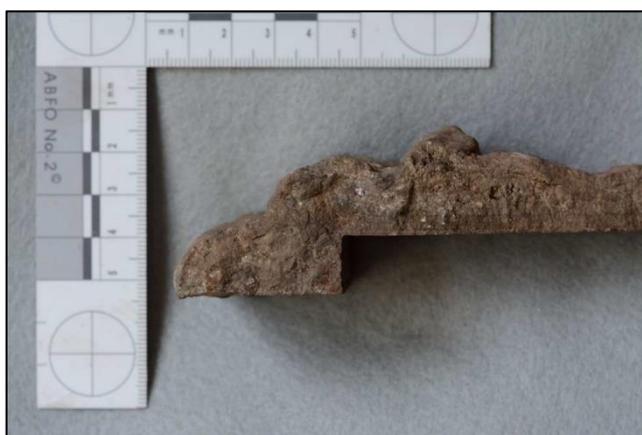
Spoil removal continued in the condenser pit of the Cornish Engine House. There was a general tidy-up mid-June, when the stone stockpiles were sorted out and encroaching wildflowers removed. A piece of scale was found during the tidy-up, which had been uncovered at an earlier work party and put to one side. On examination it was seen to have been deposited on the outside of a large (around 12") diameter pipe as the concave side was smooth and the convex side rough. The cross section showed that the scale had been deposited in many thin layers (photo [14](#)). On one work party in July many pieces of lime scale were recovered, several of which appeared to have been deposited on the outside of a structure made from two pieces of wood fitted together at a right angle (photo [15](#)). Another piece had been deposited on a sharp right-angled corner (photo right, 5 cm x 5 cm scale). The smooth surface suggests that it had been deposited on a metal sheet.

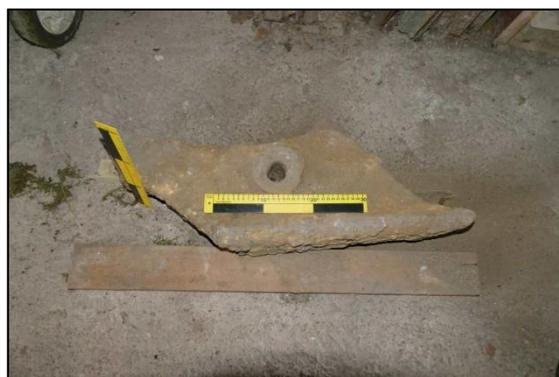
A fragment of what is thought to be the cast iron beam (photo right, two 30 cm scales) was found about 9 feet below floor level. The (approximately) 21" x 15" x 3" piece weighs an estimated 2 cwt and took two strong men to lift and move it. Photo [19](#) is a close-up of the pivot point for some of the ancillaries, which has become elliptical in shape due to wear. According to the 1930s notes of George Watkins, the Bristol-base photographer of steam engines, the beam was 24' long, 3' 6" deep at the middle and weighed 11 tons. This suggests that we have recovered just a small part of it, raising the question as to why the scrap metal workers had left this piece behind. It may be that the pit was full of water at the time and it was not considered to be worth the effort of trying to recover this small part of the beam. The extent of the lime scale deposits on the walls of the vaults suggest that the whole area was one big sump that was filled with water up to the base of the arched roofs. The photo on the right shows the northern corner of the north-east vault, and photo [20](#)

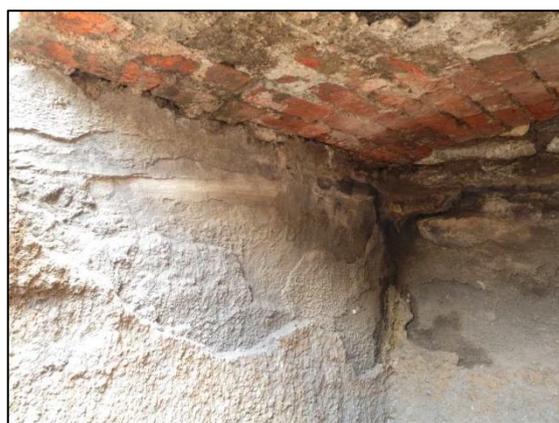
the eastern corner. There does not appear to be any access from this part of the engine house to the underside of the engine bed. We know that there is a space under the engine bed, which would be used at intervals to tighten the engine holding down bolts. It may be that the door to this space is in the north-east wall. Work on the outside of the wall in 2012 uncovered an area of uncompacted soil, but this oddity was not fully investigated at the time. That is another item on the 'things to do' list.

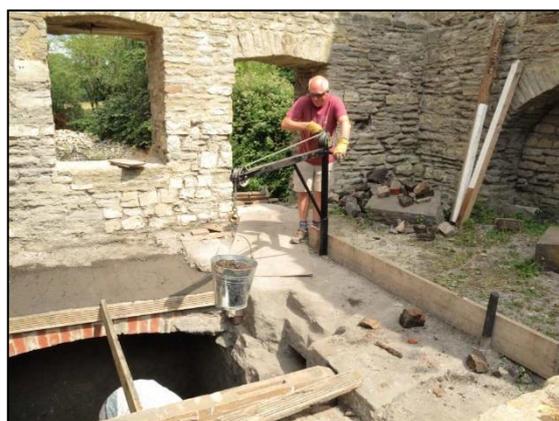
By early July, so much spoil had been removed from the condenser pit that it was no longer possible to lift a full bucket by hand onto the main floor of the engine house. Jeff constructed a mini crane to do the job instead, and the photo on the right shows Mick using it to raise a bucket of spoil. Rather than just dumping the spoilt, some of it is being used as the filler in the weak screed mixture that is being laid as the subfloor in various parts of the engine house. Up till now this involved an amount of double handling, as the contents of one wheelbarrow were sieved into another, with the lumps being tipped into a third. Hamish came up with the clever method of sorting the spoil into lumpy and sandy fractions as it slid down the chute. As can be seen from photo [21](#), it consists of a screen at the end of the chute with two wheelbarrows side by side. The photo also shows the sandy material falling through the screen into the left-hand wheelbarrow and the lumps passing over it and falling into the second wheelbarrow. The art of making a good separation between the two fractions lies in the rate at which the material is tipped down the chute. Too fast results in a sizeable amount of the sand being mixed with the lumps and so being lost to the dump. The sand is being stored in jumbo bags. Photo [22](#) shows one bag suspended from a scaffolding frame as it is being loaded, while the frame is being moved in photo [23](#) to allow another bag to be loaded.

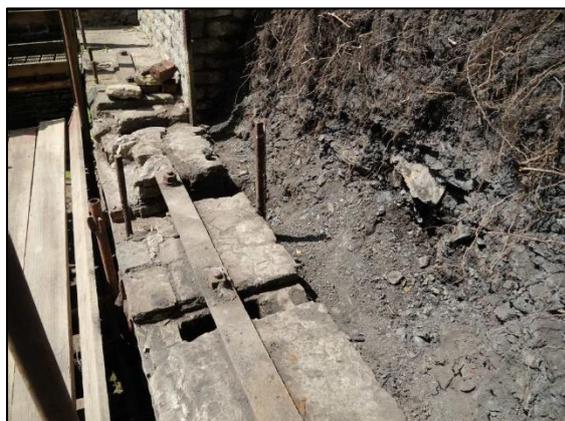
Photo 1 – Spoil from the batch has been removed from the outside of the north-west wall of the Vertical Engine House, so that it is ready for rebuilding ...

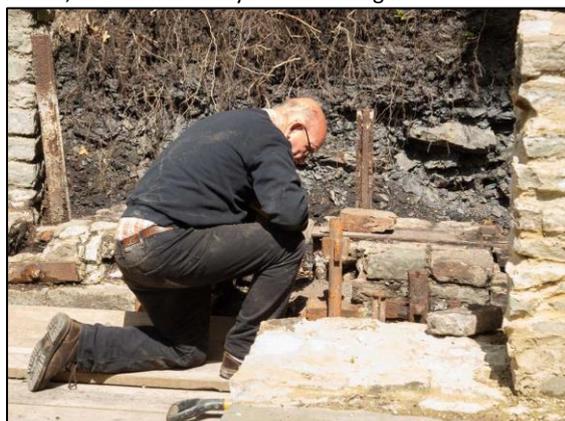
Photo 2 – ... Mike preparing the top of the wall of the winding drum pit for the rebuild ...

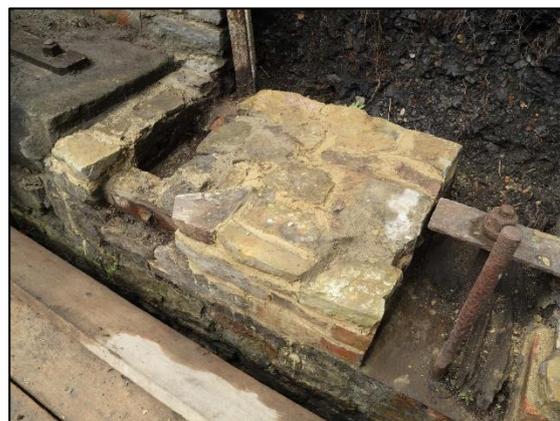
Photo 3 – ... and a section of the rebuilt wall.

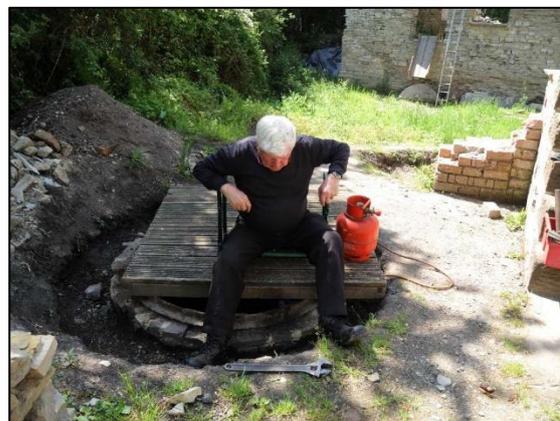
Photo 4 – Jeff getting ready to remove the nuts holding the ring down at the top of the water shaft outside the entrance to the Vertical Engine House, using some heat and a large adjustable spanner ...

There was also more work on the water shaft outside the entrance to the Vertical Engine House. Jeff unbolted the metal ring from the top (photo [4](#)) and it was taken off-site for conservation. The masonry at the top has been repaired. Photo [7](#) is a view down the shaft before the safety cage, made by Jeff, was fitted while photo [8](#) shows the cage in place.

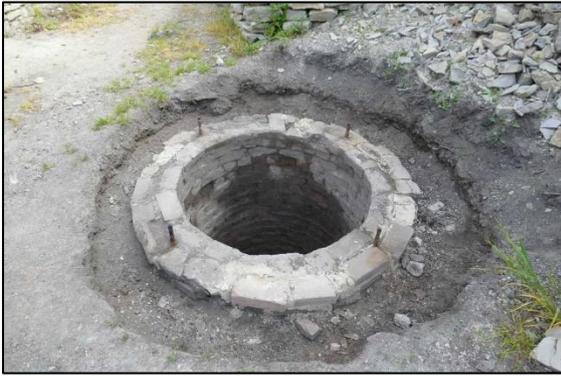
Photo 5 – ... The nuts and iron ring have been removed ...

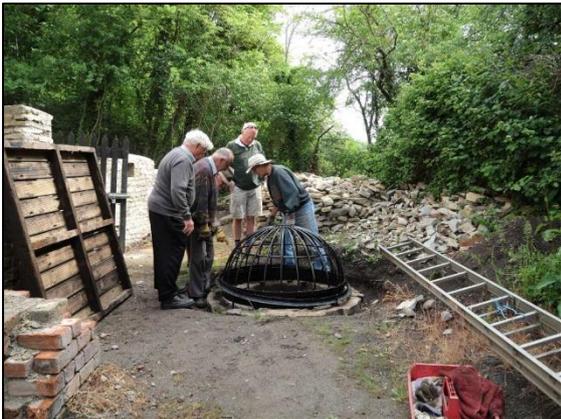
Photo 6 – ... A discussion as the safety cage is lowered into place on a trial run ...

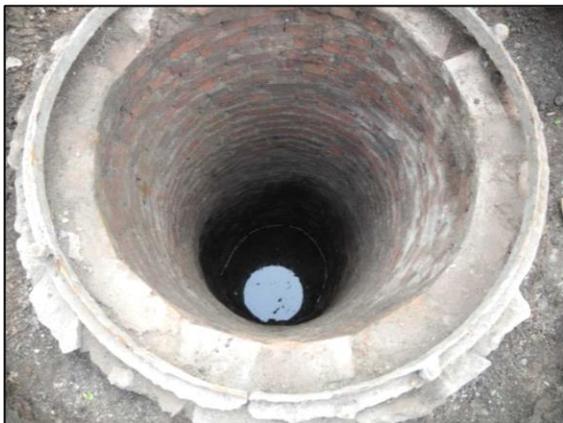
Photo 7 – ... and a view down the shaft before the safety cover was fitted.

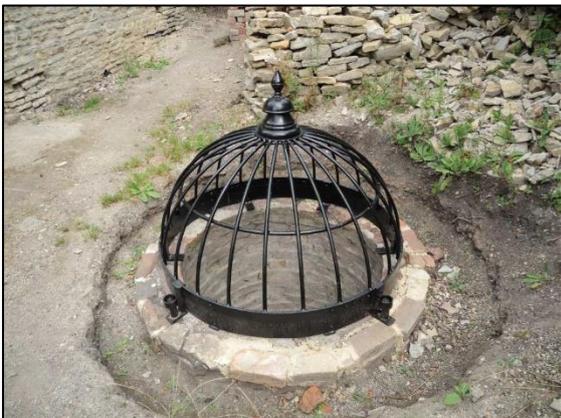
Photo 8 – The safety cover in position and bolted down.

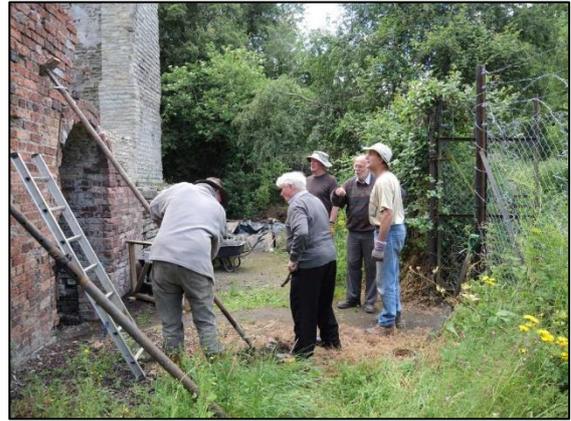
Photo 9 – Hamish and Jeff fitting the second Acrow prop at the south-west end of the Old Pit heapstead, while Mike, Ken and Pete look on ...

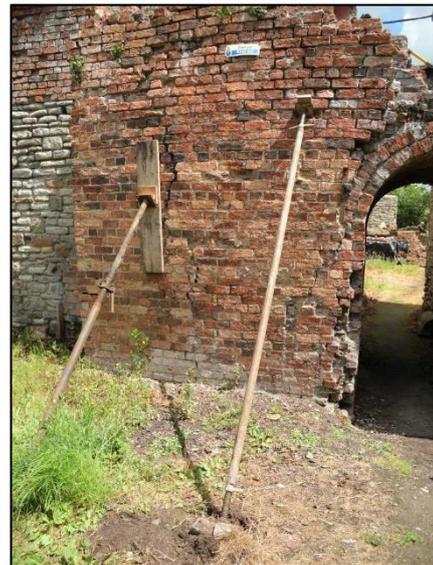
Photo 10 – ...The second Acrow prop in place. This was removed later in the same work party when the tie rods were tightened ...

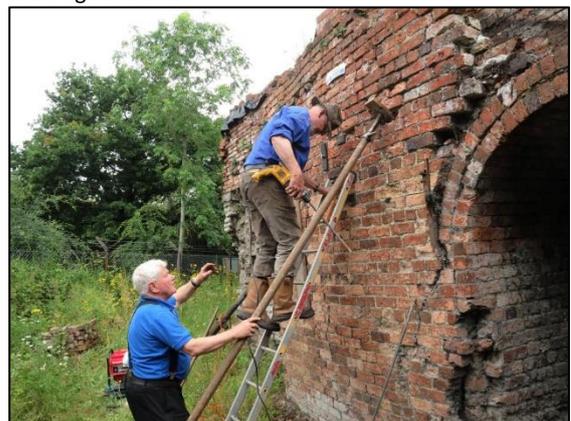
Photo 11 – ... Jeff and Hamish drilling holes for the new tie rods ...

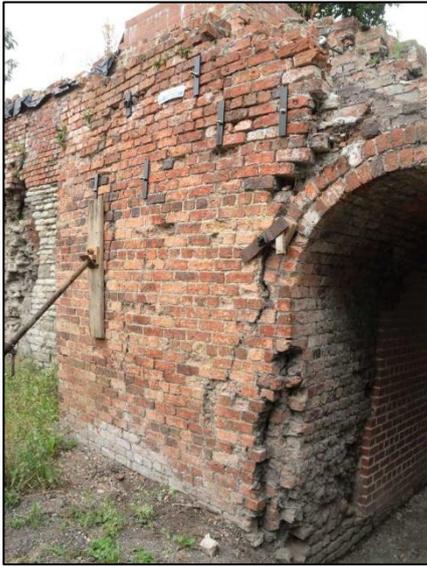
Photo 12 – ... The five new tie rods have been installed, and two existing ones refurbished.

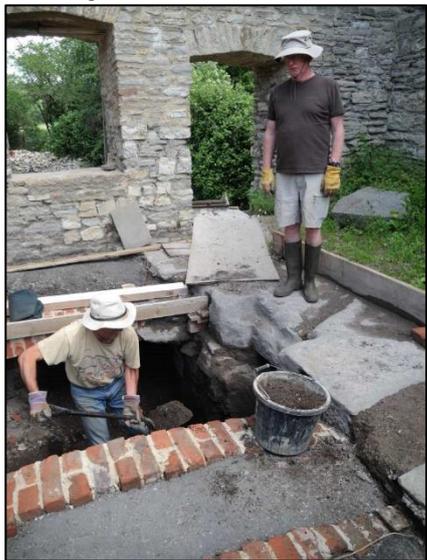
Photo 13 – Pete shovels spoil out from under the floor level of the Cornish Engine House, while Mick waits to empty the bucket of spoil down a chute situated in the doorway behind him. The other end of the chute can be seen in photo [21](#).

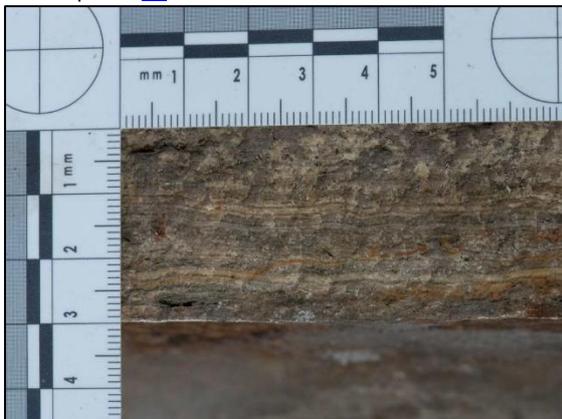
Photo 14 – Cross section through a piece of scale found in the Cornish Engine House, showing how it has been deposited in layers. (See [p.2](#), 5 cm x 5 cm scale)

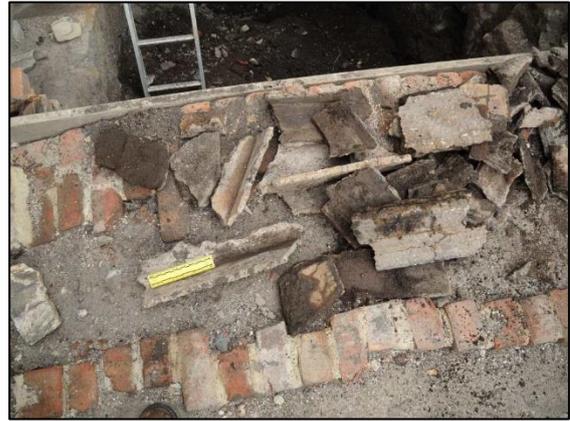
Photo 15 – Collection of lime scale found in the vaults of the Cornish Engine House. Several have been deposited on the outside of a wooden form with a right-angle joint. (15 cm scale)

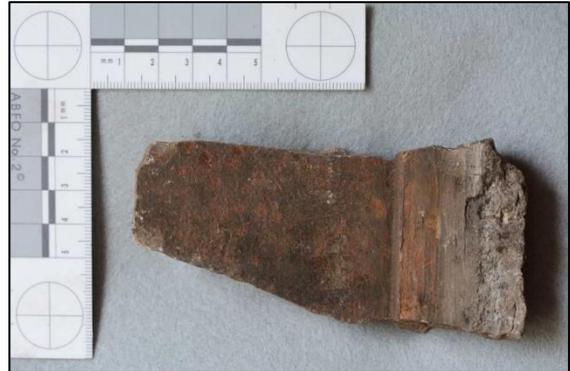
Photo 16 – Lime scale deposited on a smooth surface with a sharp right angle. (See comments and another photo on [p.2](#), 5 cm x 5 cm scale)

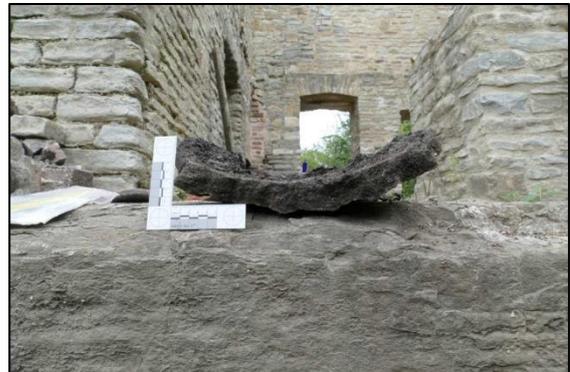
Photo 17 – End on view of a piece of lime scale deposited on a large diameter object which may have been a pipe. (See comments on [p.2](#), 5 cm x 5 cm scale)

Yet another piece appears to have been deposited on the outside of a large diameter curved object, such as a pipe. Measurements suggest that the diameter of the object is in the region of 18". The curvature can be seen in photo [17](#), while photo [18](#) is a view of the internal face of the object. There is a short length of smooth deposit, seen around the artefact ID number at the bottom, while the rest is rough.

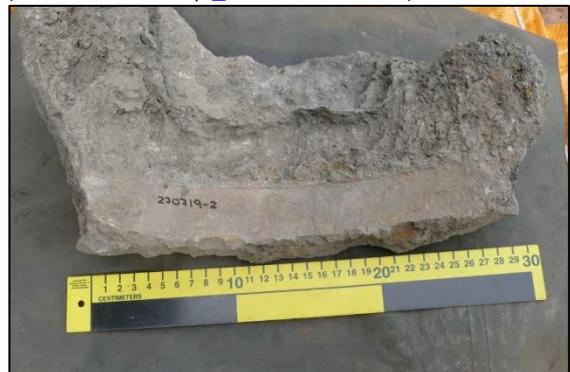
Photo 18 – View of the inside of the piece of lime scale seen in the previous photo. (30 cm scale)

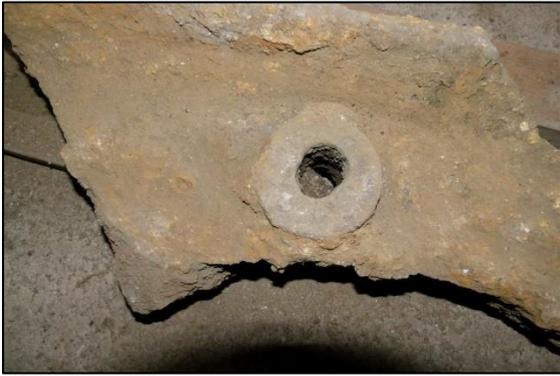
Photo 19 – A close-up of the pivot point of the fragment of the cast iron beam seen in the picture on p.3, showing that it has become elliptical in shape with use. The internal diameter of the hole varies between 1½” and 1¾”.

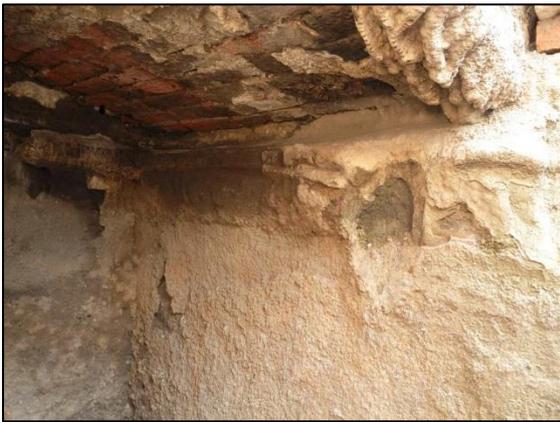
Photo 20 – Lime scale deposited on the walls of the north-eastern vault in the Cornish Engine House. This view of the eastern corner shows that the deposit reached up to the base of the brick arch. (See also the photo on p.3)

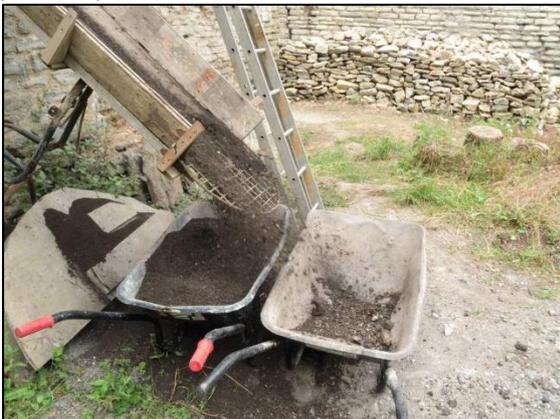
Photo 21 – The sieve mentioned on p.3 at the end of the chute. The lumps of oversize are the dark grey spots against the grey walls of the right-hand wheelbarrow.

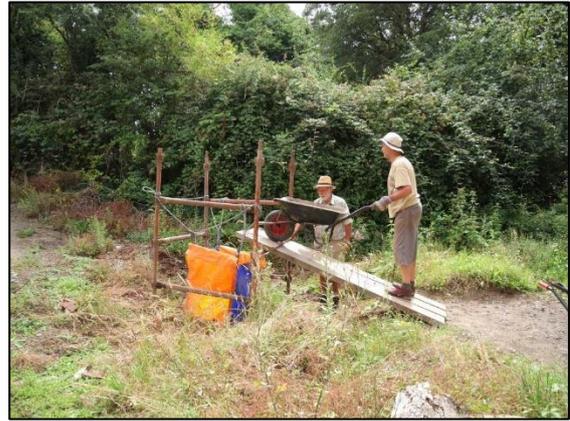
Photo 22 – Pete about to dump a barrowload of fine spoil into a storage bag suspended from a scaffolding pole frame, while Ken looks on.

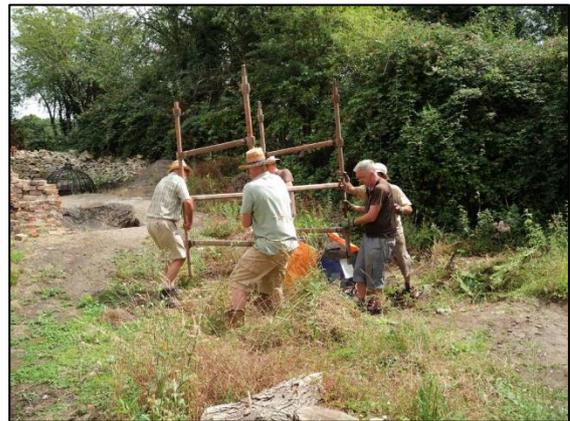
Photo 23 – Ken, Hamish, Mick, Pete, and Mark moving the scaffolding frame so that another bag can be filled.

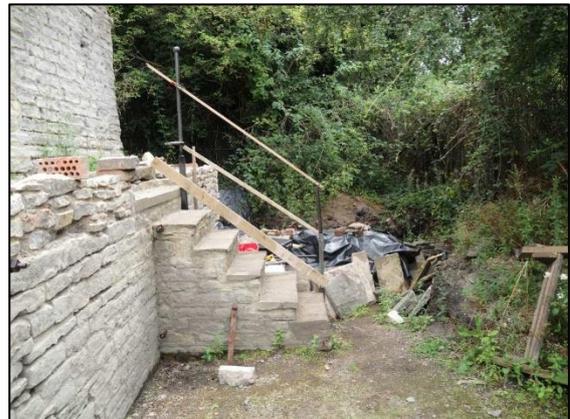
Photo 24 – The railings for the steps outside the Cornish Engine House are being measured for size before final welding takes place.

Jeff has been working on the railings for the steps outside the south-west wall of the Cornish Engine House and brought part of the structure to the site in early August (photo [24](#)). After checking the alignment, he took it away to finish the welding. The intention is to have the railings in place by the Heritage Open Days weekend.

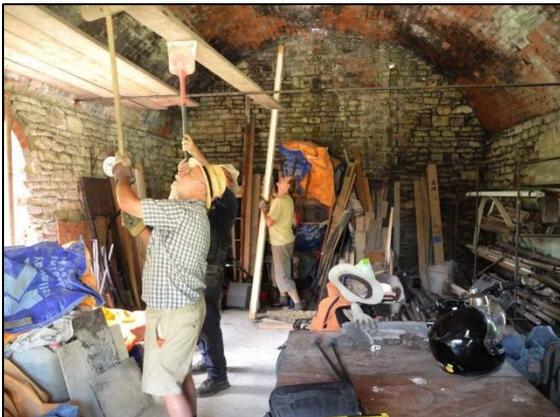
Photo 27 – Ken, Mike and Pete stow scaffolding planks on top of the tie rods in the Horizontal Engine House, saving space on the floor for other items.
