Friends of Brandy Bottom Colliery Pucklechurch

Newsletter N° 26, February 2020

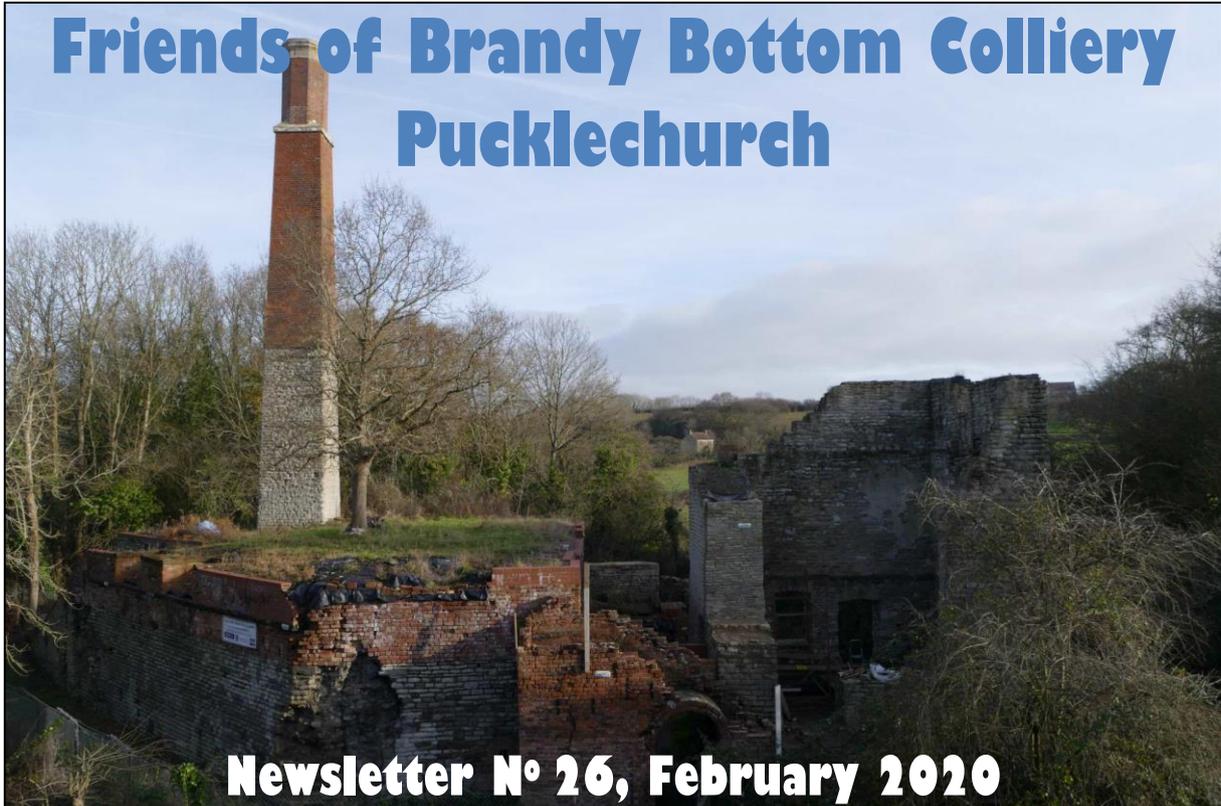
(Photos 1-26 are on page 3 onwards. The photo above, showing the chimney, Old Pit heapstead and the Cornish Engine House, was taken from the top of the Horizontal Engine House in December 2019. The photo shows the area in winter, and can be compared to the summer and autumn views seen in Newsletters 24 and 25 respectively)

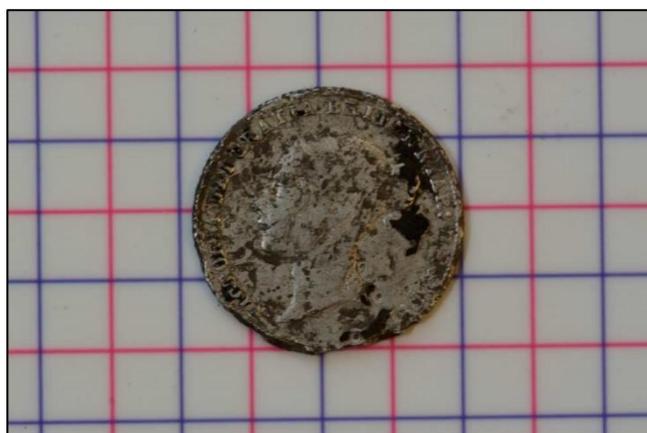
A Victorian 1859 6d piece was discovered in some spoil as the last newsletter (N° 25) was being written, and is the only coin found so far at Brandy Bottom. It is in very poor condition, worn and with broken edges. The obverse (photo right, 5 mm grid) has a bust of the young Queen Victoria, while the reverse has the words 'six pence' enclosed by an oak wreath surmounted by a crown. Records show it would have been minted from a 92.5% silver alloy.

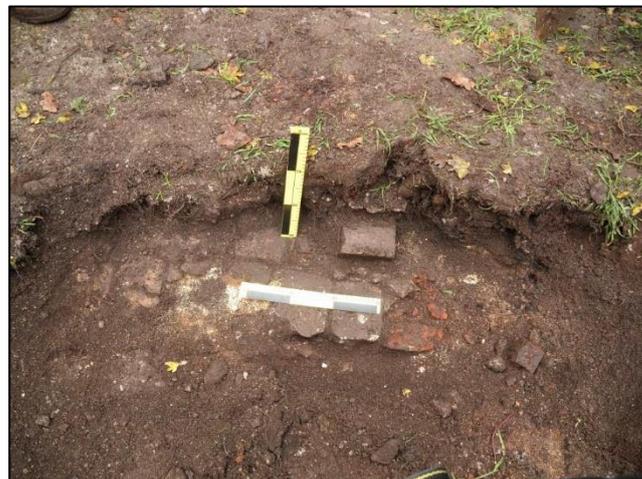
Photo 2 – A close-up of the brickwork found buried under the area used for spoil storage. (See comments on [p1](#). 30 cm scale)

In November a space had to be levelled in the New Boiler area to take another bag to hold the fine spoil excavated from the condenser pit (photo [1](#)). Digging out the top layers of the ground uncovered the brick structure seen in photo [2](#) and probing with a rod suggested that there is a firm surface some 1½ feet below the level of the bricks. Much to the regret of the diggers, this had to be covered up again after photographing the area - Partly because the space was needed for the bag and more importantly because there are too many unfinished items on the current 'to do' list. We have long thought that this area would hold the foundations for the two Lancashire boilers mentioned in the 1900 sale catalogue and intend to return to explore it at a later date.

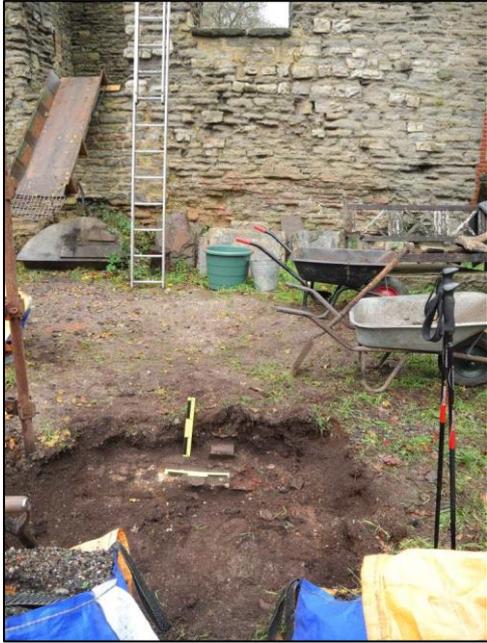
Photo 3 – A location shot for the previous photo. (30 cm scale)

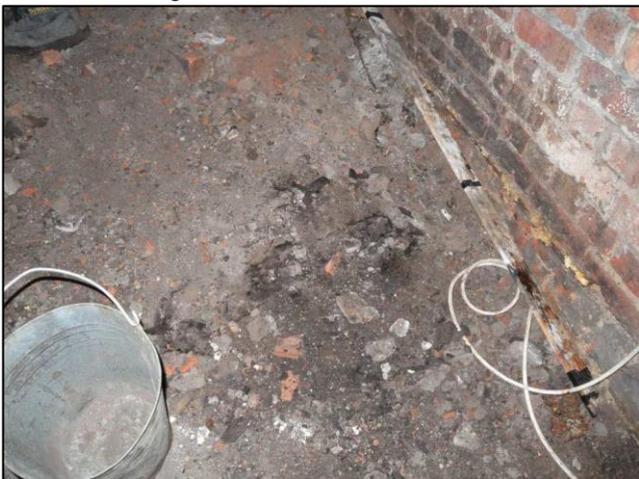
Photo 5 – The partially cleared floor of the undercroft, showing the dark tarry layer under the rubble. This photo was taken a short distance in front of the metal bucket in the previous photo.

There was further work in the undercroft of the Horizontal Engine House on three rainy days in October and November, the sort of days that are fortunately rare. Rubble was removed from the central aisle, uncovering a layer of a tarry material. This is probably a mixture of the grease used on the winding ropes with oil from the machinery and has quite a strong smell. Photo 6 shows a recovered bull-nosed brick coated with the stuff. It can be removed by scraping, so the bricks can be reused at a later date. We also found three fragments of white pottery (photo 8). In the photo these have been joined together on temporary basis using Sellotape to show they form the base of a bowl or vase. There is no maker's mark on the base.

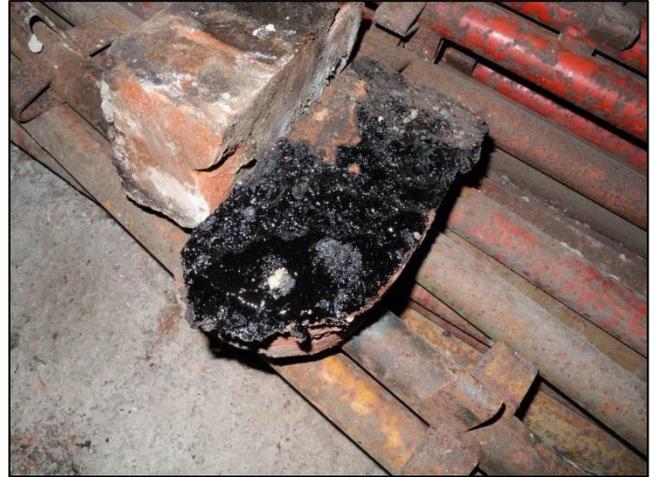
Photo 6 – A bull-nosed brick covered in a tarry-like substance. This had been found in the undercroft of the Horizontal Engine House.

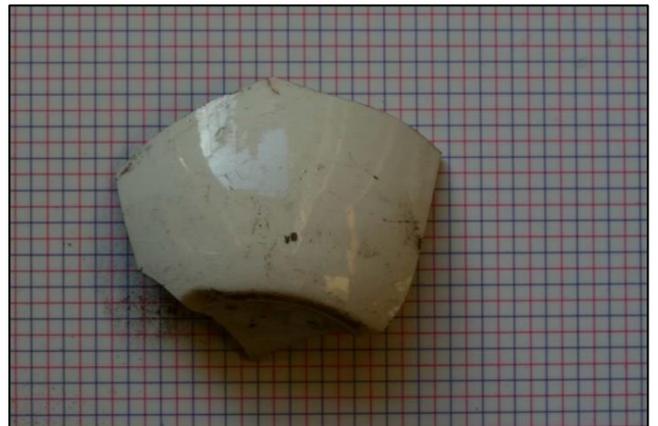
Photo 7 – One of three fragments of white pottery found in the undercroft. (5 mm grid)

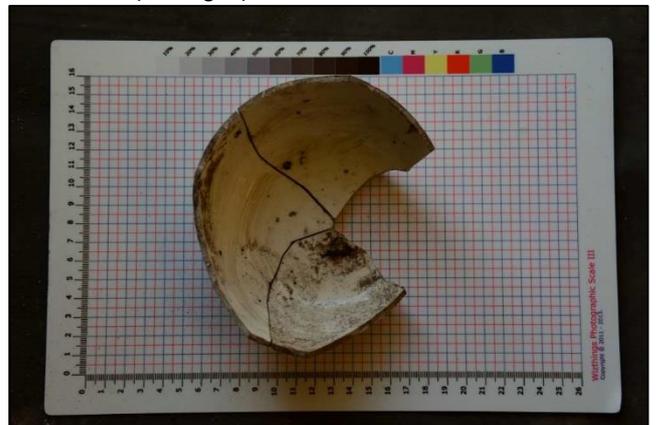
Photo 8 – The three fragments have been stuck together with Sellotape on a temporary basis to show they come from the base of the same object. (5 mm grid)

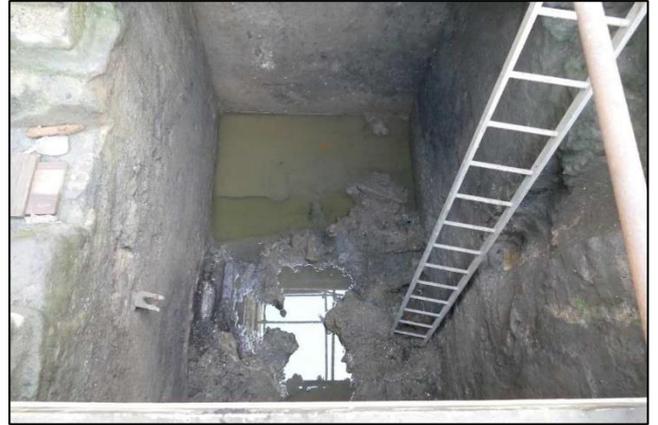
Photo 12 – The water level in the north-east of the condenser pit at the start of one work party.

More spoil was removed from the condenser pit of the Cornish Engine House. We have now reached the base of the condenser pit some 12 feet below the main floor of the building. This is below the water table and the working area has to be pumped out before work starts. Photo 12 was taken at the start of a work party in February before pumping commenced. As for the source – some of it will be rainwater, some may be ground water seeping in.

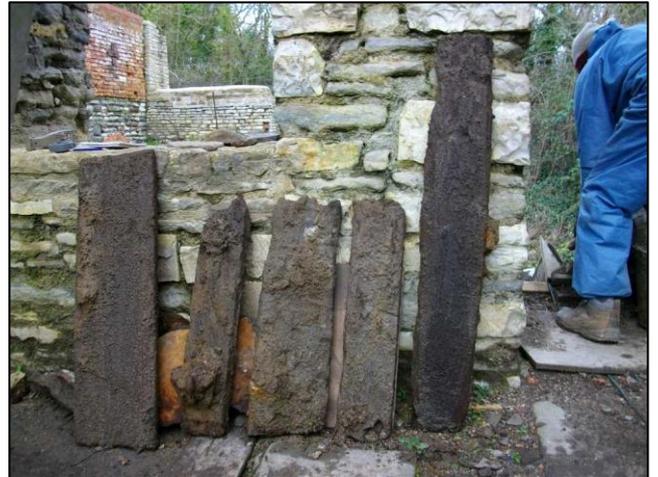
Photo 13 – Some of the wooden planks found at the bottom of the condenser pit ... (Photo: K Kemp)

A number of wooden planks have been recovered, some of which can be seen in photo 13. These may have been part of a wooden box around the condenser, similar to the one seen on the 1786 Boulton and Watt steam engine in the National Museum of Scotland in Edinburgh. (More details can be found on their website: <https://www.nms.ac.uk>. Two more planks can be seen still in-situ in photo 14, which also shows how wet the bottom of the excavation is. The artefact seen on the right was found buried in the spoil at the bottom of the pit. The left-hand side in the photo is made of a rubbery material, which is attached to the metal plate on the right. Exactly what it did is still a mystery. Another find is a piece of glass tubing, which may have been used to show the water level in a vessel.

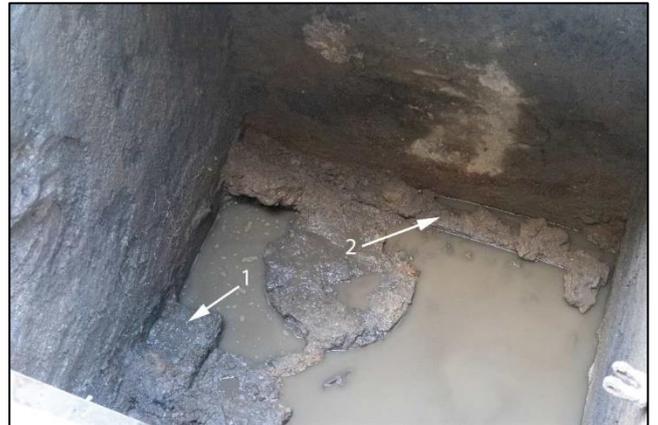
Photo 14 – ... with two more, marked by arrows, still in situ at the south-west end.

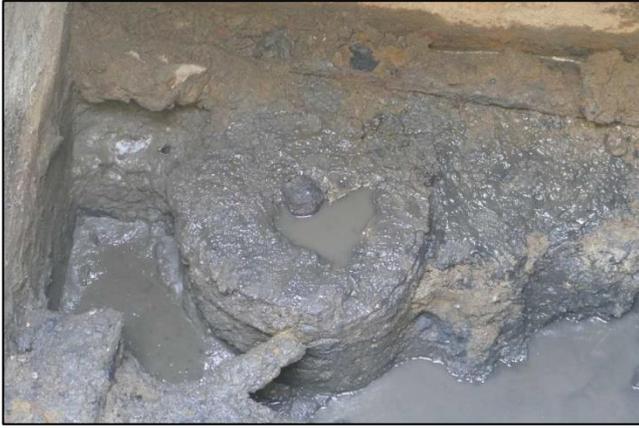
Photo 15 – This strange structure is at the south-west end of the condenser pit. It has what appears to be a wooden plug in the middle, which can be seen in close-up in the next photo.

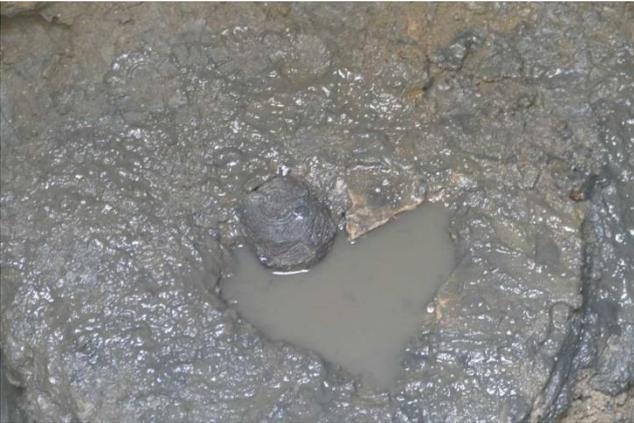
Photo 16 – Close-up of the wooden plug seen in the previous photo.

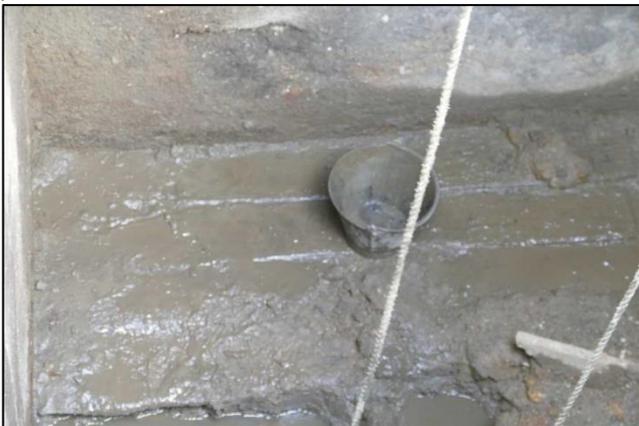
Photo 17 – Wooden planks embedded into floor of the north-east end of the condenser pit.

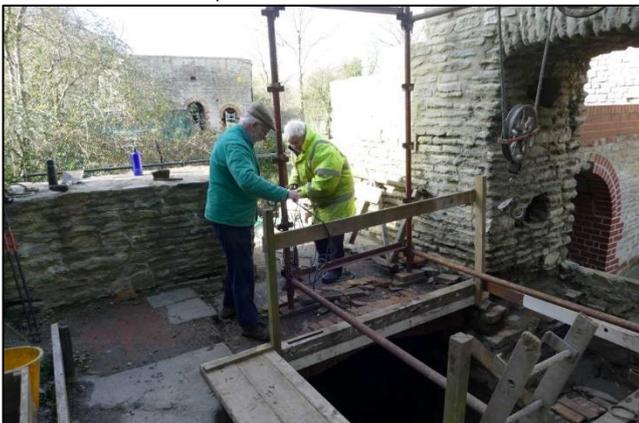
Photo 18 – Ken and Jeff setting up the pump used to dewater the bottom of the condenser pit.

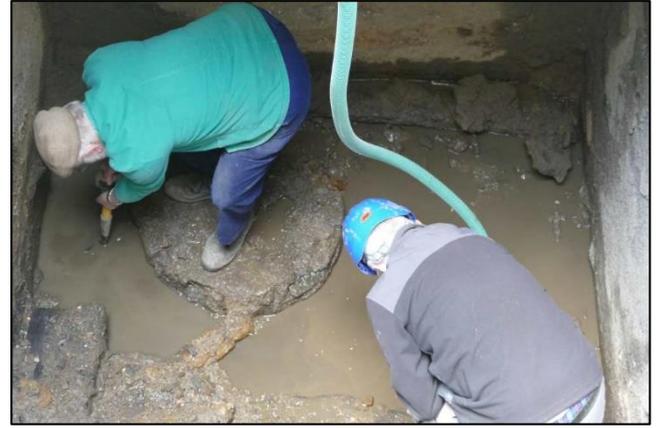
Photo 19 – Ken digs out sludge from the south-west end of the condenser pit, while Mark works the delivery line from the pump. The structure Ken is standing on can be seen more clearly in photo 15 opposite.

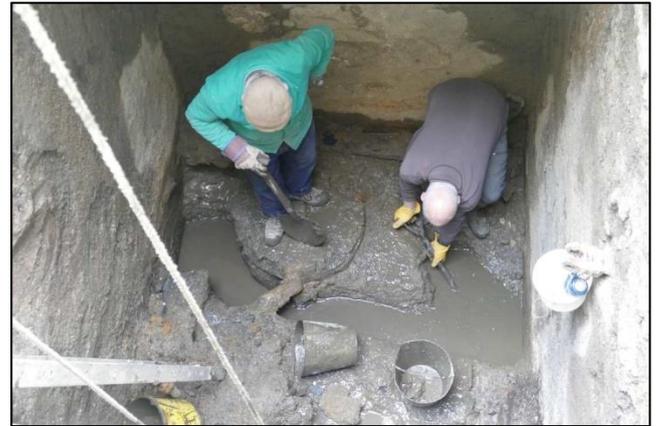
Photo 20 – Ken watches Mick digging sludge out of a sump at the south-west end.

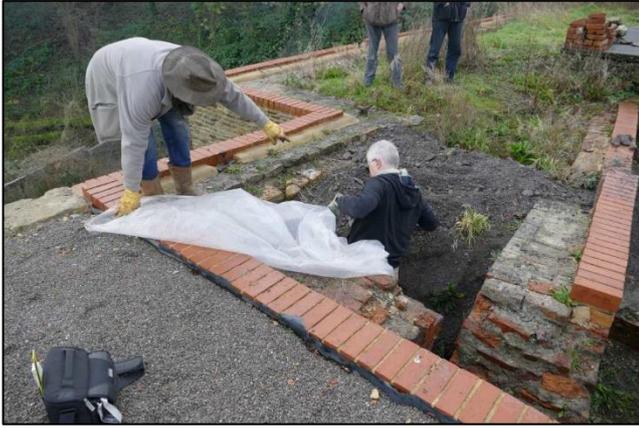
Photo 22 – ... and covers the base of the excavation with a plastic sheet, helped by Hamish.

There was also some preparatory work on the top of the New Pit heapstead ahead of the arrival of the contractors. The intention is to lay a waterproof membrane above the line of the passageway between the Horizontal Engine House and the heapstead proper. This will protect the brick roof of the passage from frost damage in winter. Drains will also be laid to stop rainwater pooling in this area. The piece of light railway points seen on the right (30 cm scale) was discovered when a piece of loose concrete on the path side of the heapstead was lifted. Some parts of the rails show signs of heavy wear, so it may have been dumped after replacement. The lump of concrete, which

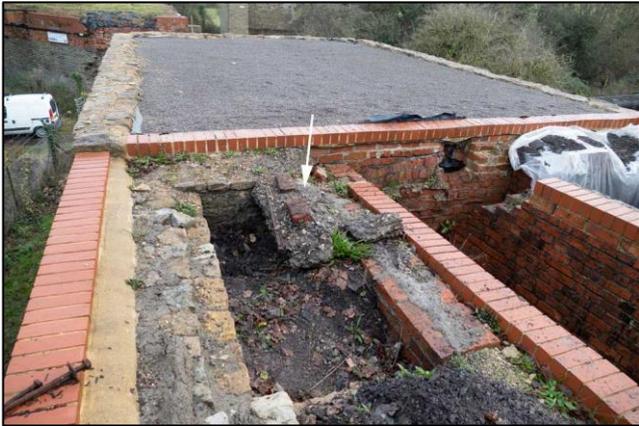
Photo 23 – A lump of concrete on the top of the New Pit heapstead has been marked with an arrow. As mentioned on p.2, it concealed a piece of railway points ...

has some light gauge rails were embedded in it, can be seen marked with an arrow in photo [23](#). Photo [24](#) shows the artefact lying where it was found under the lump.

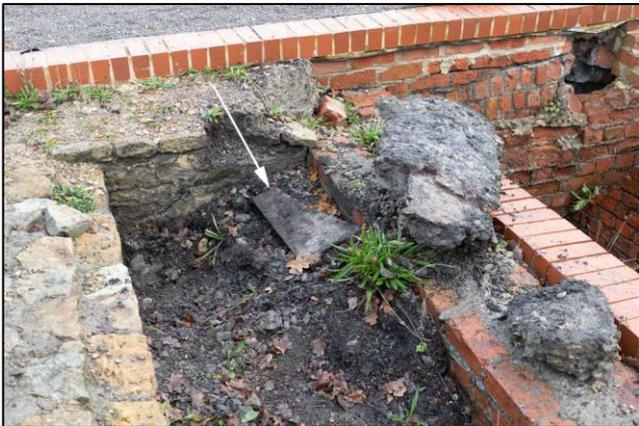
Photo 24 – ... whose hiding place has been marked with an arrow.

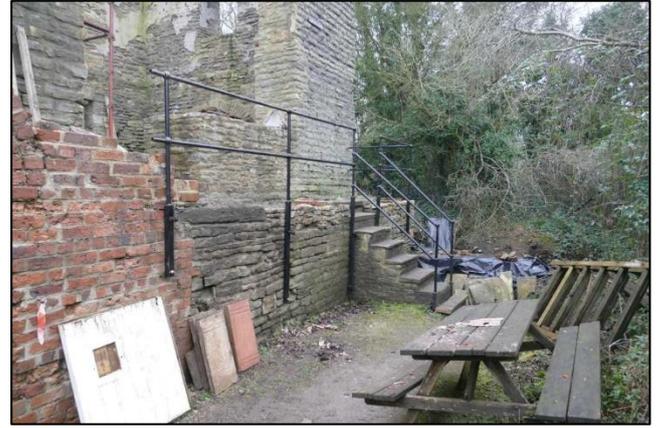
Photo 25 – Completed safety railings along the platform outside the south-west wall of the Cornish Engine House.

As can be seen from photo [25](#), Jeff has completed the safety railings around the platform outside the south-west wall of the Cornish Engine House.
