# Friends of Brandy Bottom Colliery Pucklechurch

## Newsletter N° 30, February 2021

### Progress: November 2020 – February 2021

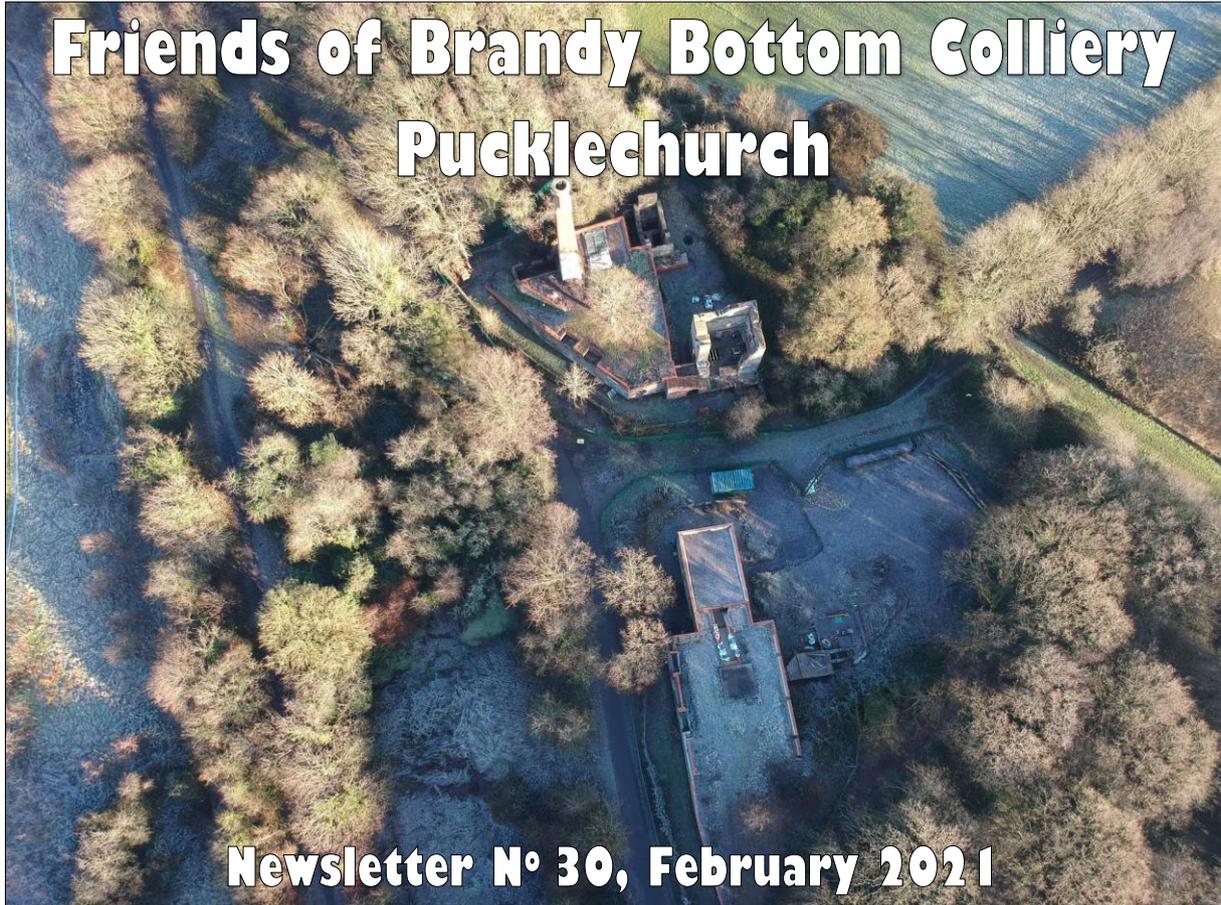
Photo 1 – Tarquin took this aerial view of the site on frosty day at the end of December 2020. It shows the New Pit at the bottom, with the pond area on its left and the new storage area on its right. The Old Pit, chimney and Cornish Engine House are towards the top of the photo – see comments on [p.2](#). (© Tarquin Powell 2020).

Tarquin flew his drone over the site at the end of December and has very kindly allowed us to add the resulting photos to the Brandy Bottom records. He took them on a frosty December day, with the low sun casting long shadows. The Horizontal Engine House and the New Pit heapstead are at the bottom of the middle of photo 1, with the newly cleared area within the new boundary fence on the right. The pond area lies at the bottom of the photo above the word “N” while the location of the cottages seen in photo 5 is in the trees above the pond area. Photo 9 is an aerial view of the Cornish Engine House, while photo 10 is an enlargement of the top of the bob wall. It shows how the fragments of one of the pivot stones have been concreted together and is the photo “missing” from the report on p.1 of newsletter N° 29.

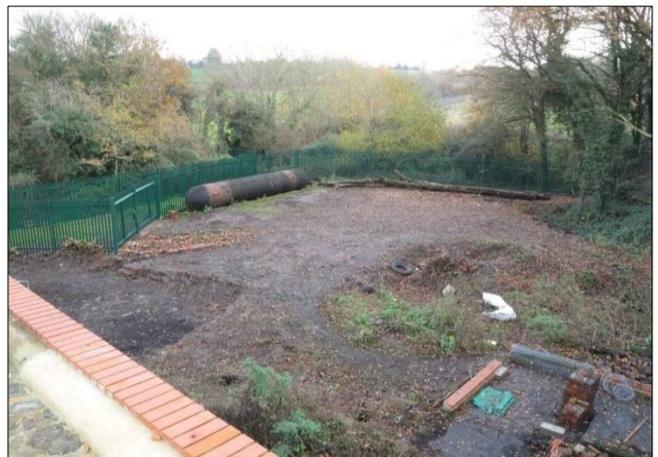
Photo 2 – View of the cleared and levelled area in the south-east of the New Pit enclosure, seen from the roof of the Horizontal Engine House.

In November we hired a JCB to level the area inside the new boundary fence on the south-east of the New Pit enclosure (photo 2, right. It also appears in the aerial view shown above) Some of this area will be used as a materials store, and there is now room for a second container if we decide another one is needed.

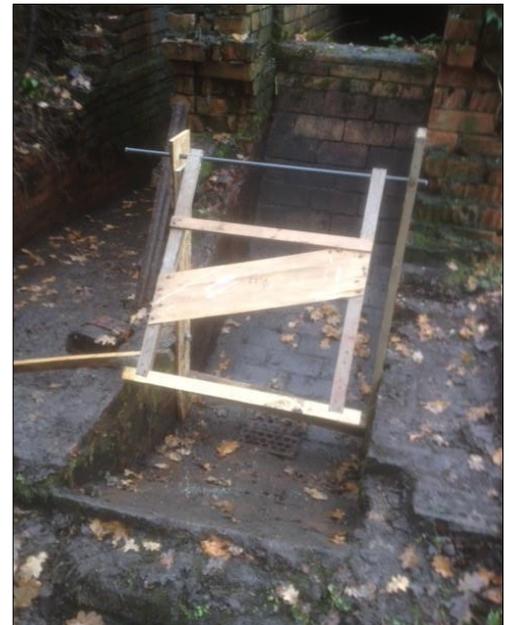
Photo 3 – Frame used by Hamish to measure the diameter of the Sirocco fan. (© Hamish Orr-Ewing, 2020)

the base of the housing when the area was fenced in at some time in the early 2000s. Fortunately for us, it had been inserted around the edge of the drainage bricks at the base of the housing, so was removed with remarkably little damage to the brickwork (photo 8). With clear access to this end of the fan ducts, we can now start on its conservation at some time later in the year. The fan duct structure is a rare example of their kind in this region, as they were easy to put up and so easy to knock down. In his 2003 book<sup>1</sup>, John Cornwell reported that the fan was of the Sirocco pattern but did not give the size. Nor did he say whether steam or electricity drove the fan. It was steam according to the Ancient Monument Scheduling, but we currently think electricity as we found the remains of a power cable near some mounting bolts at the side of the fan ducts. That raises the question as to where the electricity came from, but the same could be asked about the source of the steam. The fan first appears in the 1915 Ordnance Survey map, and by then the structure connecting the Horizontal Engine House and the Old Pit heapstead had been dismantled. That could have carried a steam pipe from the boilers in the Old Pit. If only we could find a copy of the 1936 sale catalogue as that could tell us more about the fan and its power supply. Hamish built the frame seen in photo 3 on the right so that he could measure the fan size by trial and error. Robin took an alternative approach – some measurements and a return home to a mug of tea and a textbook. It will be interesting to see if the two methods arrive at the same answer.

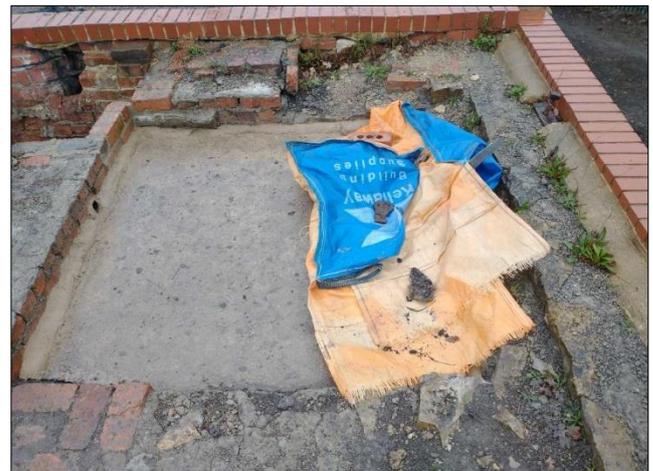
Photo 4 – This area to the south-east of the winding ramp has had the concrete floor and water-proof membrane sealed to the wall with a cement flaunch. (© Mark Bonson, 2020)

Clearing up the damage caused by the vandals in early 2020 had a knock-on effect on the work done by the masons. Because of the constraints of time and money, they concentrated on the areas that the volunteers would struggle with. As a result, some of the finishing touches were left for the volunteers to do – Little did we know that events would delay this work. One of these tasks was sealing the concrete floors of the New Pit winding ramp and adjacent pits to the brick walls. Photo 4 on the right shows the area to the south-east of the winding ramp. A cement flaunch seals the waterproof membrane under the concrete floor to the brick wall on the left of the photo to stop water by-passing the membrane. The circular object is the drainpipe that channels rainwater into the winding ramp. A second drainpipe carries water away from the base of the ramp and currently discharges into the passage below. Channelling this water away from the building is another one of the jobs that has been put on hold.

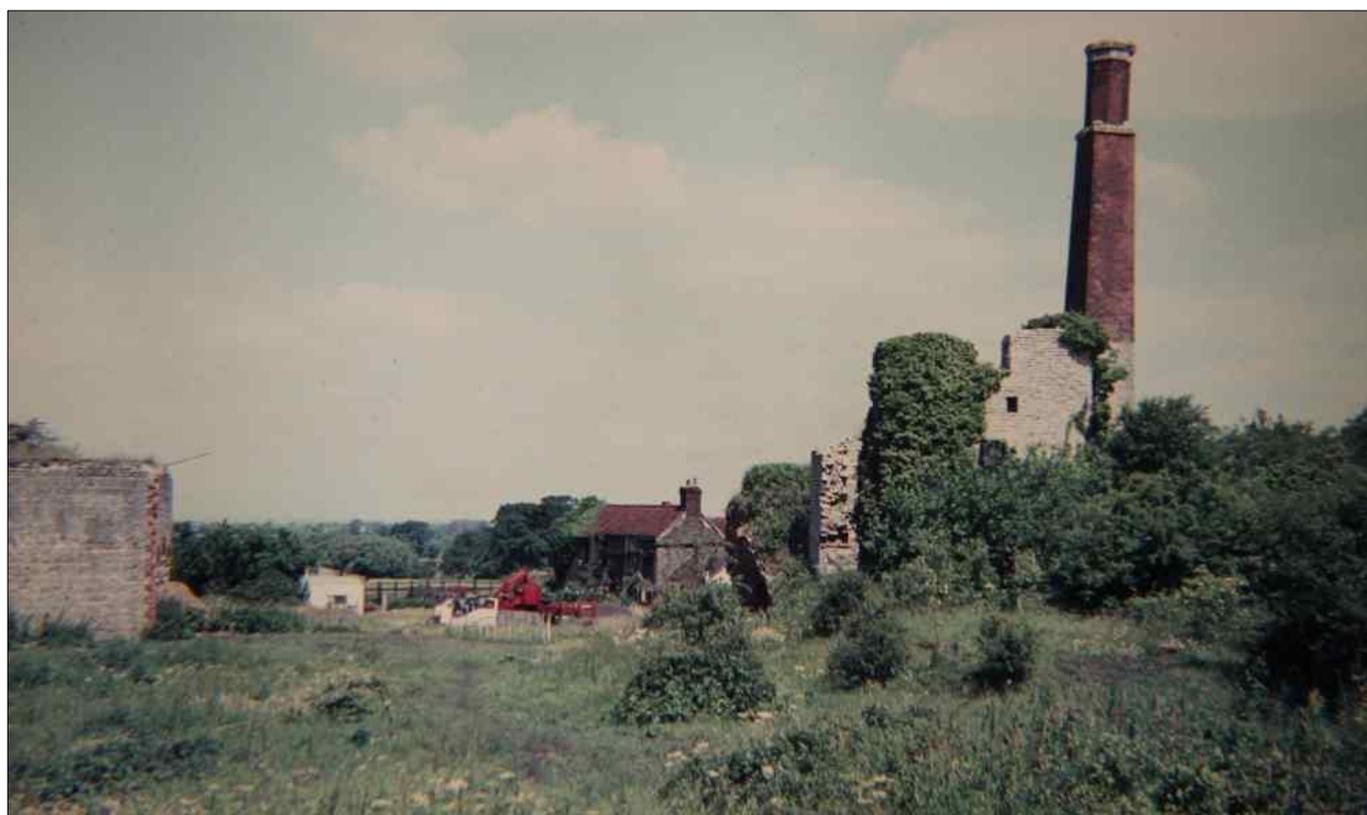
So far this is the only photo we have of the cottages and that part of the site. Examination of the Maxwell photo shows that the chimneys of the cottages are just visible over the top of the Horizontal Engine House, and judging by the angle, the white building in the distance is Grove Farm. Those of you who know the site will notice the absence of trees to the left of the cottages. Instead, there is a caravan and a piece of agricultural machinery.

Photo 5 – Brandy Bottom and the cottages, taken at some time between 1965 and 1977. (Photo by Matt Southway, © Kingswood Heritage Museum)

We think that Matt Southway took the photo of Brandy Bottom seen below at some time between 1965 and 1977, based on the following pieces of information: Jonathan Maxwell took the photo on the front of Steve Grudging's Historical Report<sup>2</sup> in 1965 and it shows the gable of the south-east wall of the Cornish Engine House to be still substantially complete. There is more ivy on the walls of the CEH in one of the photos taken by A D Wadley in 1977 (see newsletter N° 21). We would like to thank Alan Bryant of the Kingswood Heritage Museum for allowing us to add Matt Southway's photo to our Brandy Bottom records. This is the same photo published in the Autumn 2020 issue (N° 59) of the SGMRG newsletter, except that here it is in colour. There appears to be a pipe sticking out from the top of the Horizontal Engine House. It is not known what its function was – it might even be a bit of dust on the original 35 mm slide. Software was used to clean the digital copy of the slide of what looked like the specks of dirt and small hairs attached to the original.

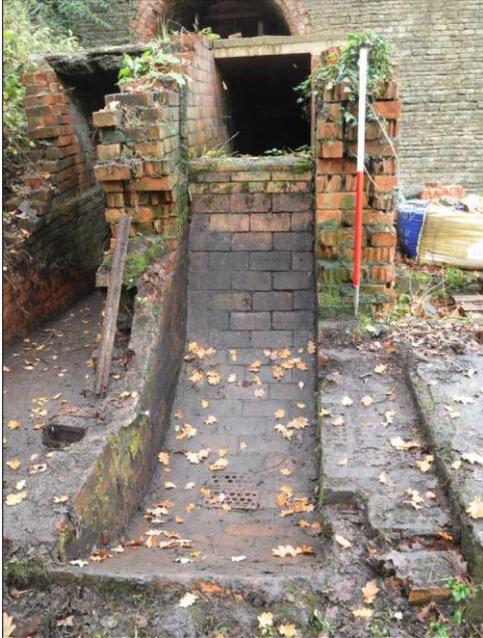
Photo 6 – A view of the fan housing from a position outside the line of the old boundary fence. The two perforated bricks that form the drain are located towards the bottom of the photo. (1m red/white ranging pole)

At the same time the old boundary fence was removed from between the container to the southern edge of the fan ducts, opening up a complete view of the latter for the first time in the project's history. Photo [6](#) was taken from outside the line of the old boundary fence, looking towards the shaft with the brick base of the fan housing in the foreground. A fence post (photo [7](#)) had been driven into

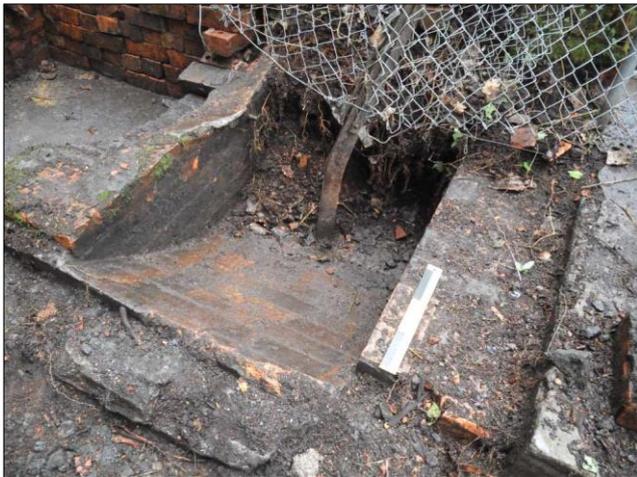
Photo 7 – This 2016 photo shows the fence pole inserted into the brick base of the fan housing. (30 cm scale at the inside edge of the right-hand brick plinth)

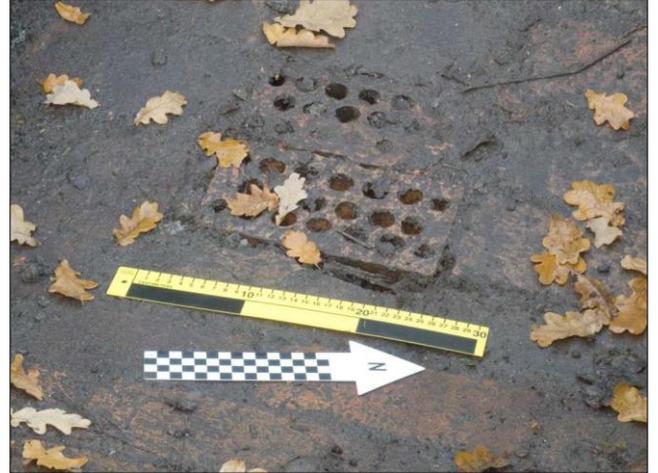
Photo 8 – The perforated bricks act as a drain at the bottom of the fan housing. The fence pole seen in photo 7 had been inserted at the corner nearest the head of the north arrow. (30 cm yellow/black scale)

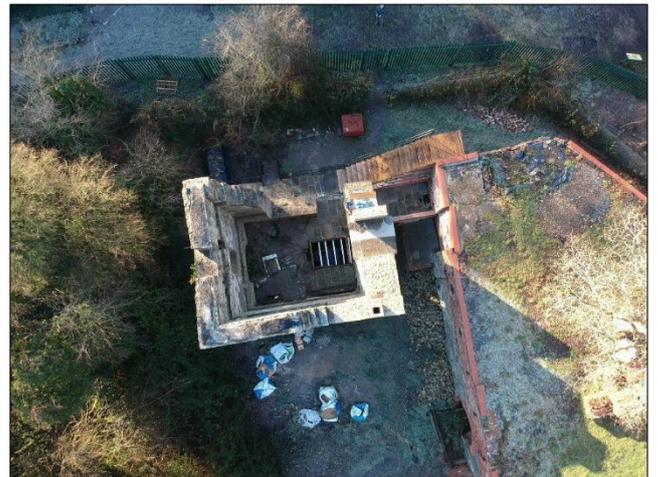
Photo 9 – Aerial view of the Cornish Engine House, with the Old Pit Heapstead on the right - See comments on p.2. (© Tarquin Powell 2020)

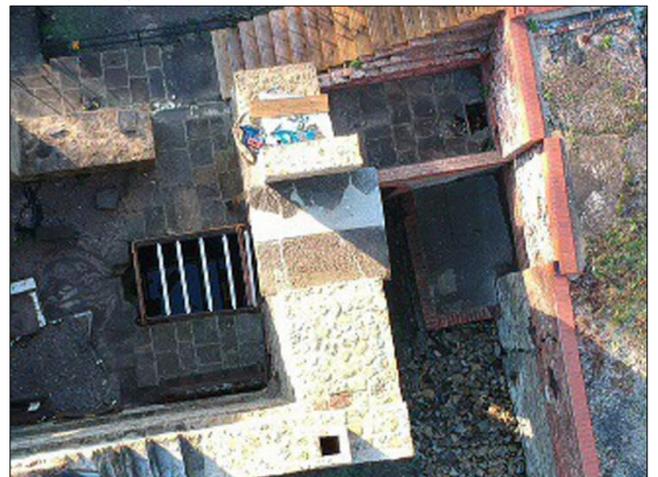
Photo 10 – This enlargement of the bob wall shows how the fragments of one of the pivot stones have been set into the top of the bob wall - See comments on p.2. (© Tarquin Powell 2020)
