# Friends of Brandy Bottom Colliery Pucklechurch

## Newsletter N° 32, August 2021

### Progress: June - August 2021

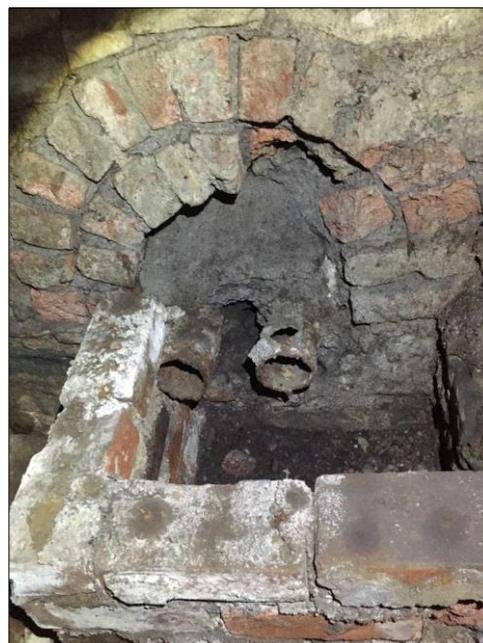
Photo 3 – Pipes sticking out of the wall in the northern corner of the undercroft of the Horizontal Engine House. (© D Hore, 2021)

Tracing has confirmed that the pipe outside the southern corner of the Cornish Engine House (A in photo [2](#)), seen in photo 25 of the previous Newsletter (N° 31) is connected to the pipe entering the undercroft of the Horizontal Engine House (photo 26 of the same newsletter). A structure (photo 3 right) in the north corner of the undercroft of the Horizontal Engine House has two pipes leading to the outside of the building (F in photo [2](#)). The signal from these pipes stopped about two feet outside the building in an area where we found a brick floor in 2012. This floor formed part of a building that appears in the 1936 Ordnance Survey but not in the 1915 one. At one time this structure in the undercroft was called a 'miner's font' but closer examination shows that is unlikely to have been watertight. It has therefore been renamed as a 'pipe box', as its function would appear to have been to protect the pipes.

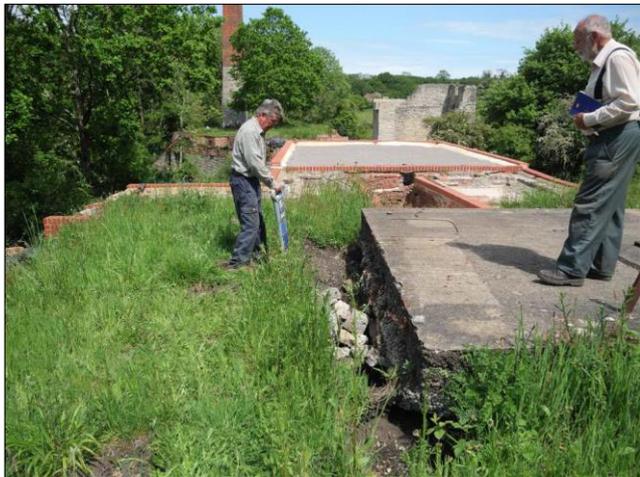
Photo 6 – Derek traces the course of the metal pipe on the top of the New Pit heapstead, while Ken looks on.

Pipe tracing continued in June, and photo [6](#) shows Derek at work on the top of the New Pit heapstead while Ken looks on. As reported in the last newsletter (N° 31), a pipe at the base of the north-west wall of the New Pit heapstead had been traced as running underground to the conduit above the pond (B in photo 2 on the right). This pipe must have originally run up the wall of the heapstead as we discovered a section sticking out of an area of damaged wall during restoration work in January 2017 (photo [7](#)). As this part of the wall facing was to be rebuilt, a length of modern pipe was fitted over the original so that it protruded through the new wall face to mark the spot (photo [8](#)). Tracing confirmed our earlier suspicions that the pipe on the top of the heapstead ran towards the New Pit shaft. In 2012 we discovered a metal pipe when clearing the ground outside the north-west wall of the Horizontal Engine House (photo [10](#)). At the time we did

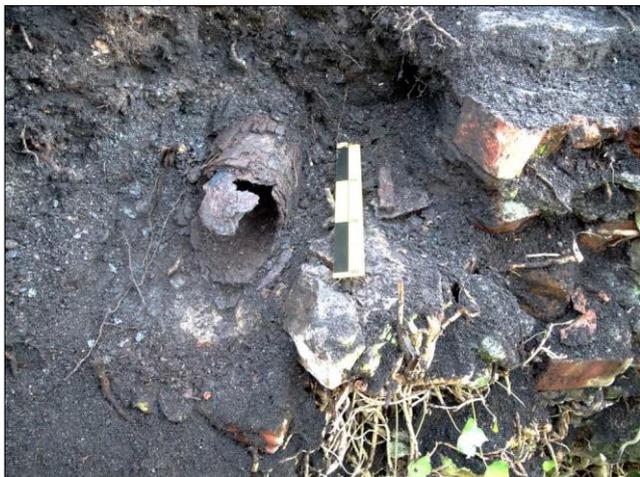
Photo 7 – Pipe uncovered in 2017 when the top of the north-west wall of the New Pit heapstead was cleared of vegetation and loose masonry before rebuilding. (30 cm black/yellow scale)

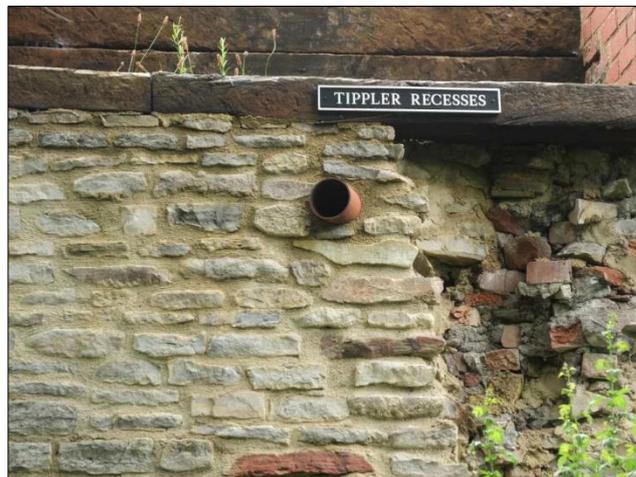
Photo 8 – A modern extension has been fitted to the pipe seen in the previous photo, and the wall facing rebuilt around it. The top arrow in the next photo (9) points to where the pipe can be seen protruding from the wall.

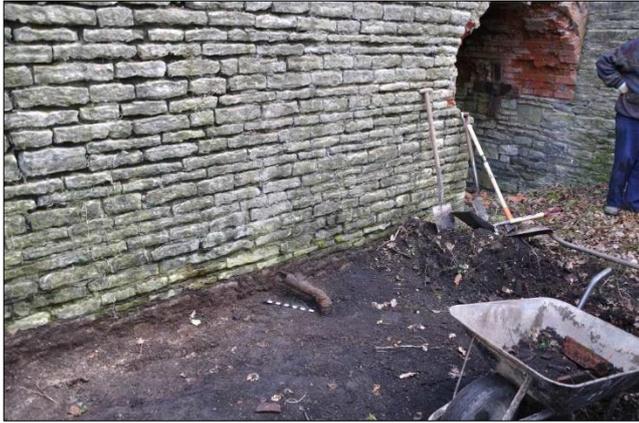
Photo 10 – This 2012 photo shows the pipe uncovered outside the north-west wall of the Horizontal Engine House (See comments on [p.1](#)). (12 in black/white scale beside the pipe)

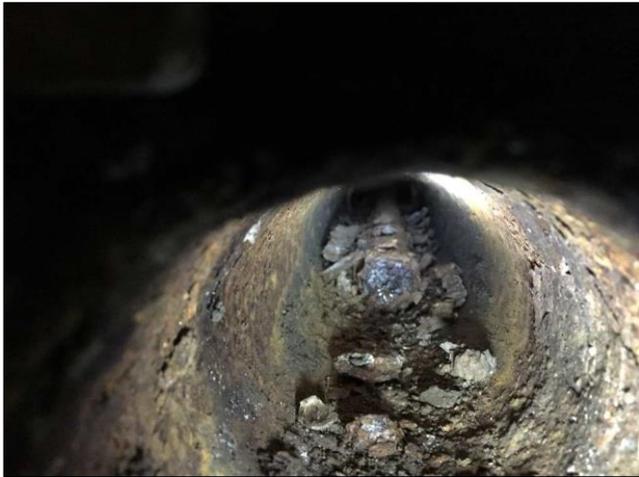
Photo 11 – The left-hand pipe in photo [3](#) has an object inside ... (© D Hore, 2021)

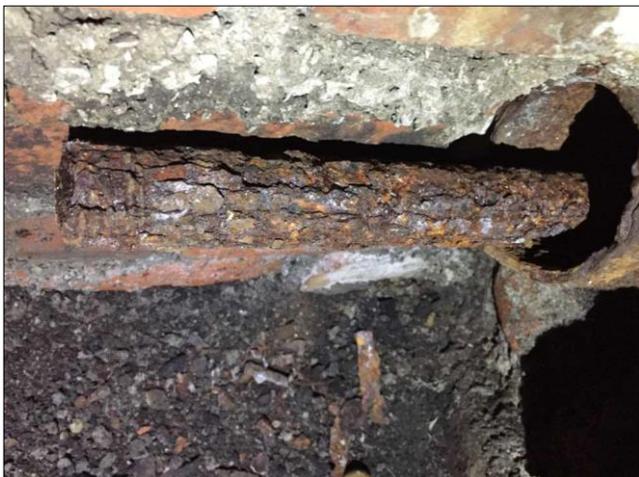
Photo 12 – ... which turns out to be an iron bar with what looks like a thread at the end. (© D Hore, 2021)

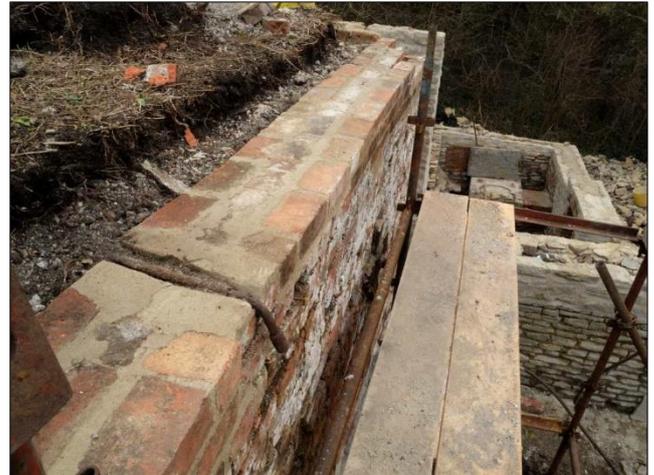
Photo 14 – Pipe discovered during the rebuild of the top of the south-east wall of the Old Pit heapstead in March 2016. (See comments on [p.2](#))

Another attempt was made to trace the route of the heavy-duty electric cable found beside the fan ducts (D in photo [2](#)). The signal was again lost by the eastern corner of the Horizontal Engine House, suggesting that the cable had been severed in this area. The final pipe to be traced was one discovered in 2016 when the top of the south-east wall of the Old Pit heapstead was being capped (photo [14](#) and E in photo [2](#)). This runs parallel to the south-west wall of the building next to the chimney. It runs about 2' away from the wall and at a depth of about 2' below surface and stops around the eastern doorway. Its size suggests that it was a gas pipe or electricity conduit.

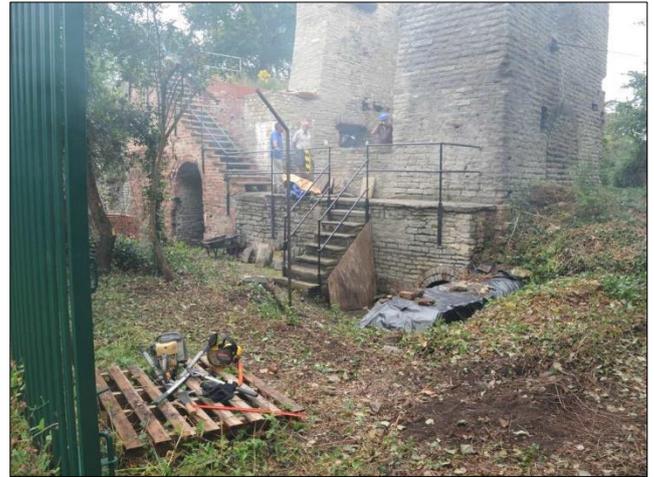
Photo 20 – This view of the south-western wall of the Cornish Engine House was taken from the new wide gate. The black polythene sheet is covering part of the foundations of the egg-ended boiler. Derek, Ken, and Mark B are being slowly kippered in the smoke from a bonfire on the other side of the building.

We started to remove the old boundary fence from the south-eastern side of the Old Pit enclosure, and this will give us more room to investigate the boiler foundations outside the south-east wall of the Cornish Engine House at a later date. This work can be seen in photos [15](#) to [21](#), while photo [20](#) shows the improved view of the southern corner of the Cornish Engine House. Most of the fence posts were firmly fixed into the ground and had to be eased out by Jeff using his lifting gear (photo [21](#)), assisted at times by others. While clearing vegetation in the wooded area between the old and new fences, Steve came across two flat metal bars sticking out of the ground (photo [22](#)). At first glance they appear to be the side arms of a ladder which have lost their top two rungs. Finding out what they really are will have to wait until after the Heritage Open Days.

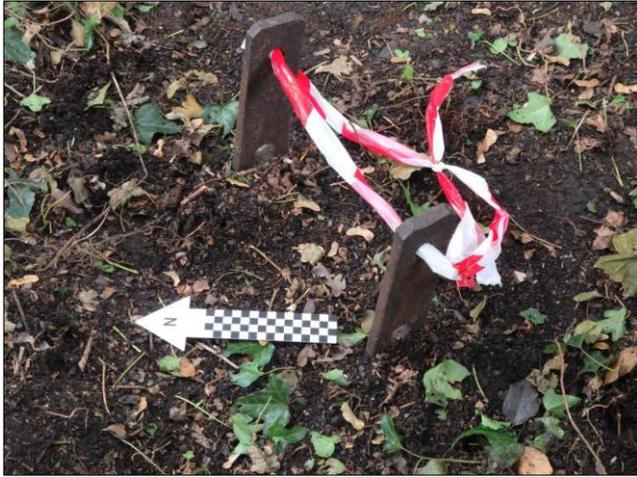
Photo 22 – Two flat metal bars were found when clearing in the wooded area to the south-east of the Cornish Engine House. The North arrow shows the orientation, and scale is indicated by the 15 cm section of black/white squares.

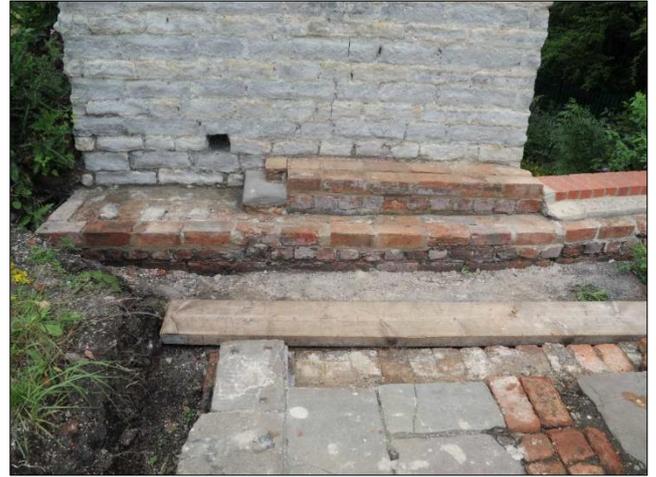
Photo 25 – Rebuilt section of wall running along the base of the south-east wall of the chimney.

Ken, Derek, and Mick have been working on the building foundations on top of the Old Pit heapstead. Some of the brickwork had to be rebuilt before the area is covered up again for protection against the winter weather. Their work can be seen in photos [25](#) to [29](#).

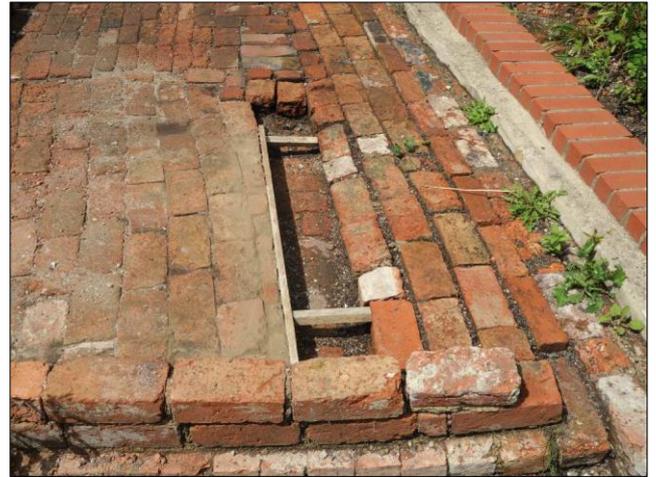
Photo 26 – Part of the building foundations on top of the Old Pit heapstead. The loose bricks to the left of the central strip of wood have now been mortared back in place. Photo [28](#) shows Mick working on this area.

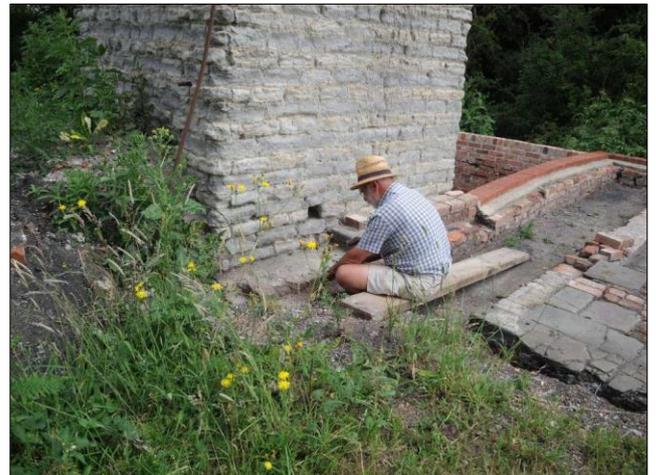
Photo 27 – Ken cutting out damaged brickwork at the base of the chimney.

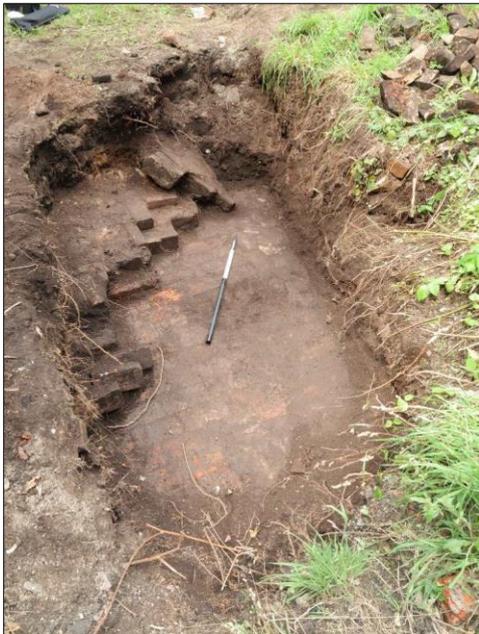
Photo 30 – The brick floor found at the bottom of an enlarged test trench in the New Boiler area. The far end of the 1 m black/white ranging pole points towards north.

Tim has been working in the New Boiler area, where his test trench has uncovered a section of flooring (photo [30](#)). The initial trench had to be enlarged once the first part of the floor was uncovered, and photo [31](#) shows the relationship between the initial trench and the north-east wall of the Cornish Engine House. We are not yet sure what this floor signifies, but the excavation has given us valuable

information on the depth of spoil covering any structures in this part of the site. It should be possible to reduce the work of the volunteers by getting a mini digger to remove some of the overlying material.

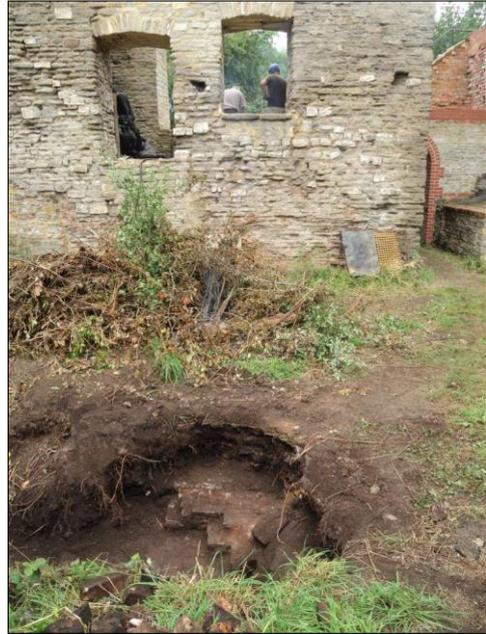
Photo 31 – An earlier photo of the test trench in the New Boiler area, showing its position in relation to the north-east wall of the Cornish Engine House.

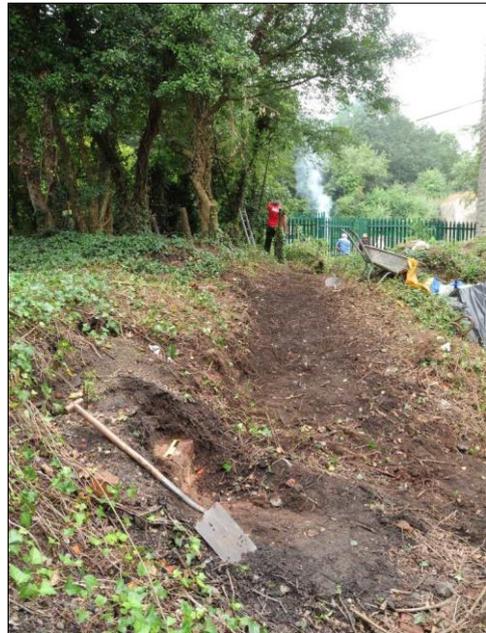
Photo 32 – The new path cut outside the south-west wall of the Cornish Engine House. The spade marks the position of the section of brick wall seen in the following photo [33](#).

Preparation for the Heritage Open Days is underway, and the tour route has been modified to try to stop people congregating at pinch points. Removal of the original fence around the Old Pit has allowed us to make a new exit from the New Boiler area by building a path built along the line of the fence (photo [32](#)). This uncovered a section of brickwork in the bank above the line of the path (photo [33](#)). The brickwork has been affected by heat so may have formed part of a flue, possibly connecting the egg-ended boiler to the chimney. Its significance is something else that will be investigated after the Heritage Open Days weekend. The new tour route enters the New Pit enclosure through the yard, so a path is being made to connect the flat area of the yard with the foundations of the Fan Engine House (photo 5 right).

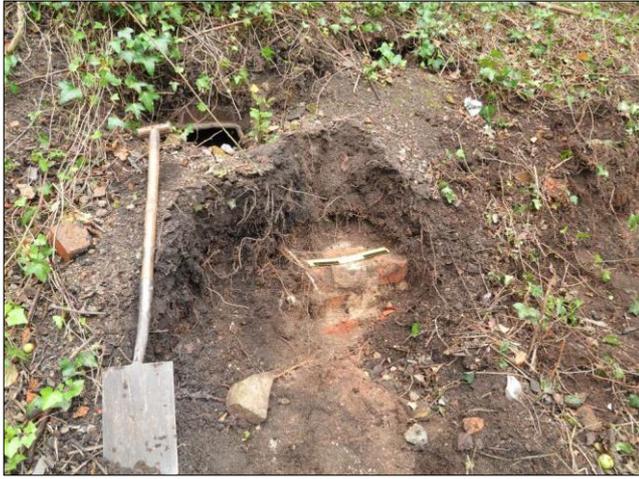
Photo 33 – Section of brick wall uncovered when building the path seen in the previous photo (32). (See also comments on p.3, 30 cm black/yellow scale)

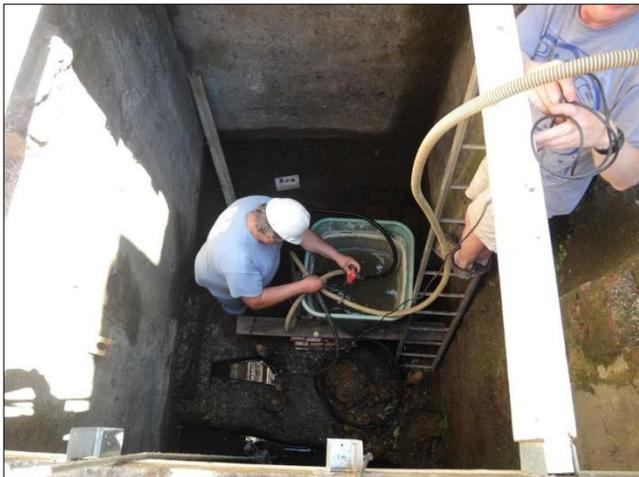
Photo 35 – Occasionally Mark B and others get to work in the condenser pit of the Cornish Engine House. Here Mark W is working at the bottom, pumping water out of the sump into a bin. The pump layout then had to be changed to pump the water out of the bin to the surface. Eventually the sludge in the bottom of the sump got the better of the pump, so it is back to the drawing board.

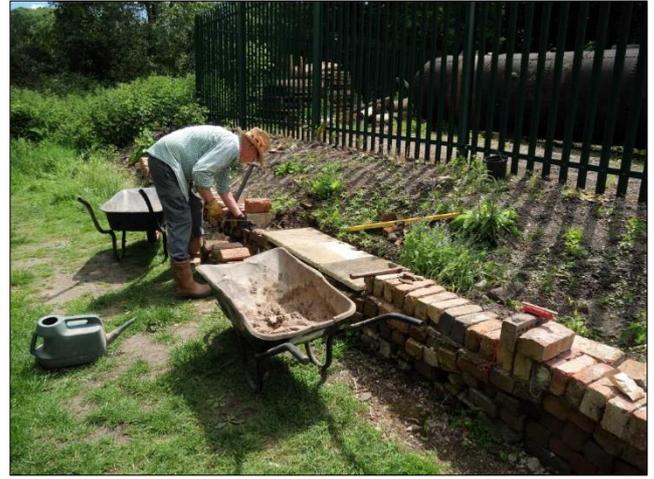
Photo 36 – Hamish laying bricks to form the retaining wall at the base of the slope near the egg-ended boiler. The flat area just above the nearest wheelbarrow is a seat that can be seen in the next photo (37).

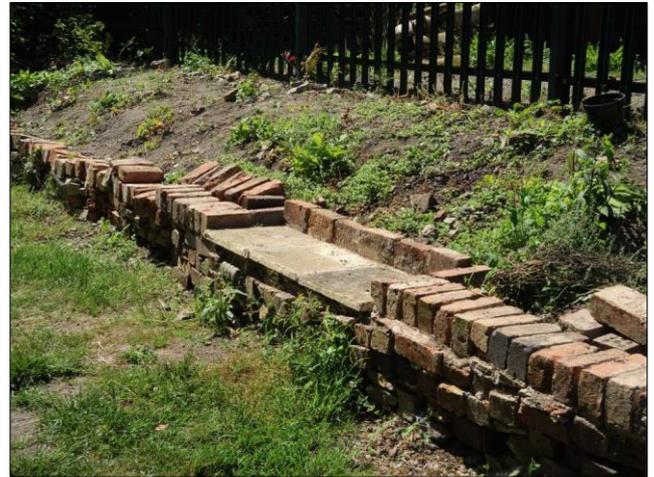
Photo 37 – The wall below the egg-ended boiler now has a seat made from stone slabs. Passing cyclists have already started to use it while eating their lunch, so a second seat has been added beyond the first one.
