# FRIENDS OF BRANDY BOTTOM COLLIERY, PUCKLECHURCH

Newsletter N<sup>o</sup> 6, February 2015

## Progress: December 2014 - February 2015

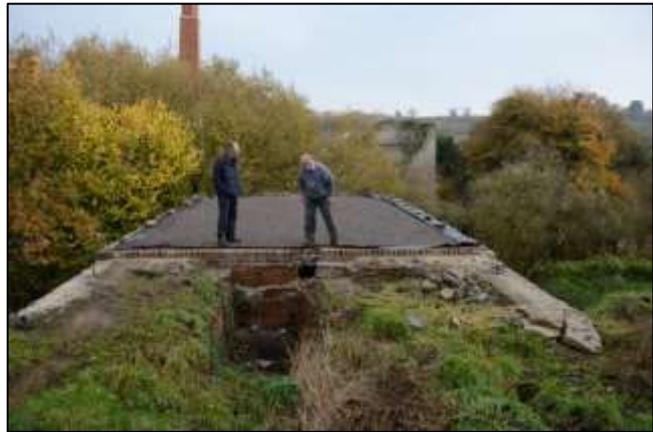
The masons completed laying the waterproof membrane on the roof of the Horizontal Engine House by mid-November 2014, though there is still some work to be done by the volunteers in securing the edges and finishing off the drains at the corners. The photo to the right shows the top in early December. Ken and Martin can be seen walking on the protective layer of gravel that covers the membrane. Somebody remarked that the gravel would make a fine pitch for a game of boules. The benefits of the membrane can be seen already, as the inside of the house has been kept dry over the Christmas/New Year break in work parties. Another, if unintentional, benefit has been the creation of a dry spot where we can shelter from inclement weather.

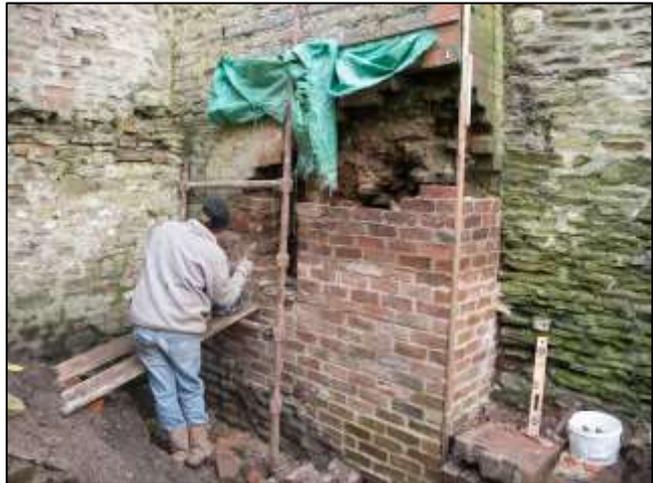
Work on rebuilding the base of the chimney in the Old Boiler House continued. The photo on the right shows progress at the end of the 06 December work party. The original flue, which is being kept as a feature, can be seen in the centre of Fig 2, which was taken on 09 November. Fig 3 shows progress towards the end of the 11 February work party, while Fig 4 is a close-up of the top of the rebuilt flue. As can be seen from Fig 3, the brickwork to the left of the flue is now complete. The base of the rebuilt section is solid brick, and above it is a brick skin, keyed to the existing masonry with wire ties and filled with concrete. The bricks used have been recovered from the debris in the floor of the building.

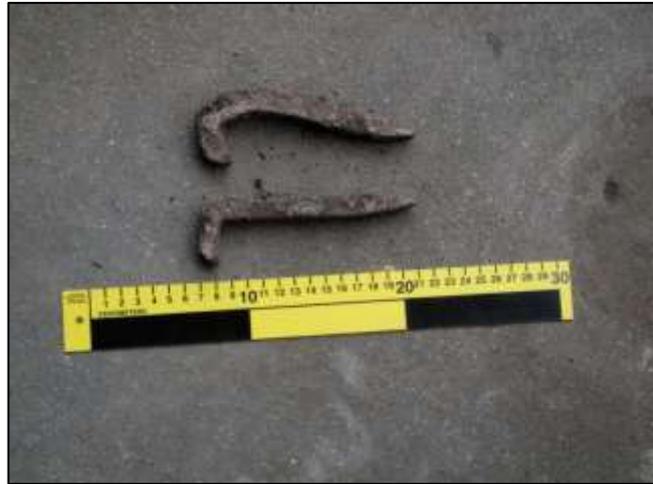
The path along the base of the north-west wall of the New Pit heapstead has almost reached the bottom of the ramp, greatly improving access to it. Among the finds were the two track spikes seen to the right.

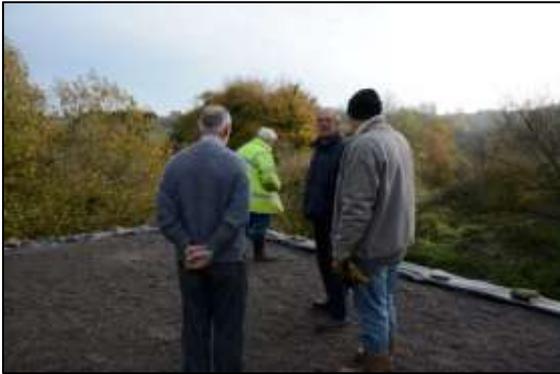
Fig 1 – The work party inspects the newly-laid membrane on the roof of the Horizontal Engine House on 19 November 14.

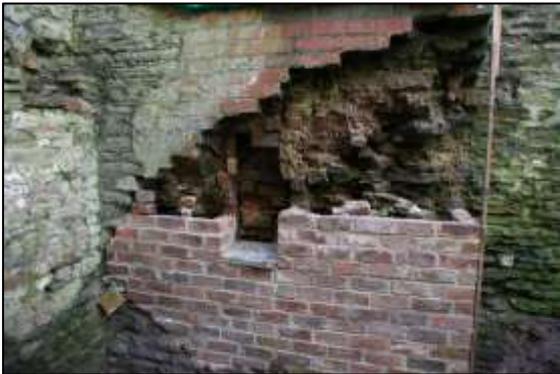
Fig 2 – Progress on rebuilding the base of the chimney on 19 November 14.

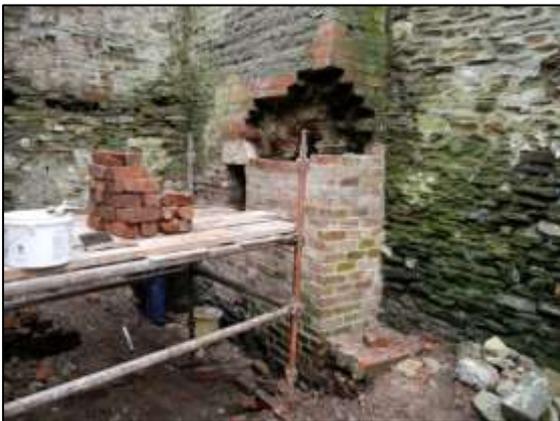
Fig 3 – Rebuild of the base of the chimney towards the end of 11 February 15 work party.

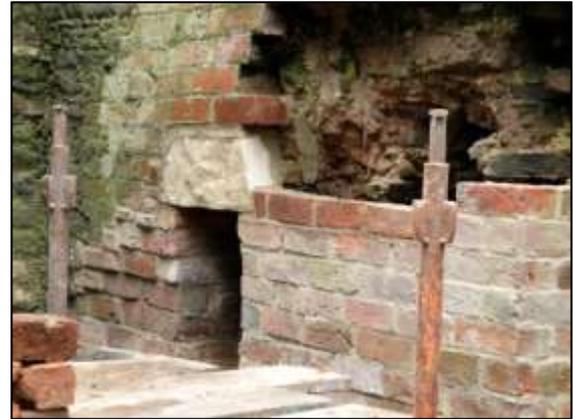
Fig 4 – Close-up of the capping stone on the top of the rebuilt flue on 11 February 2015.

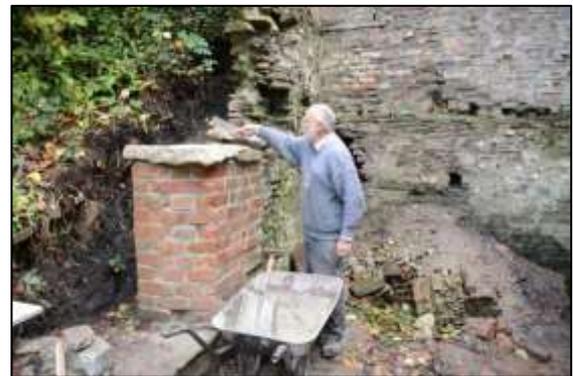
Fig 5 – The finishing touches being made to the rebuilt section of the north-east wall of the Old Boiler House.

The rebuild of the first section of the north-east wall of the same building was completed, apart from trimming the capping stones, and this can be seen in Fig 5.
