FRIENDS OF BRANDY BOTTOM COLLIERY, PUCKLECHURCH

Newsletter N^o 8, August 2015

Progress: June-August 2015

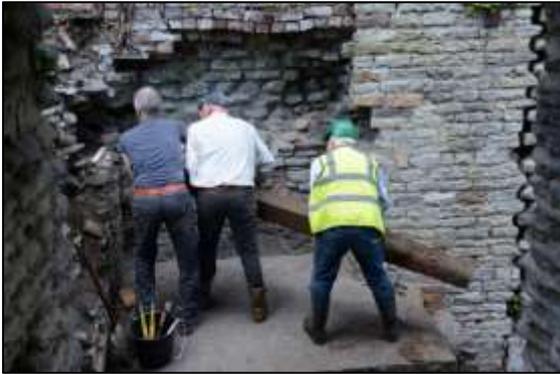
Photo 1 – Manhandling an old railway sleeper into place above the Pumping Shaft capping, where it will form part of the base for the patching of the heapstead wall.

A section of the Old Pit heapstead wall above the Pumping Shaft, where the unsupported brickwork was in danger of collapsing, was patched using recovered bricks. Two old railway sleepers were used to form a support for the re-laid bricks, and the sleepers were inserted into existing sockets in the walls on either side (photo 1). Photo 2 shows both the sleepers in place before the work started and also shows the area that had to be patched. Photo 3 was taken during patching, while the photo to the right shows the finished section of the wall. Two of the existing courses of bricks had to be removed and re-laid, as they had become partially detached by ivy roots.

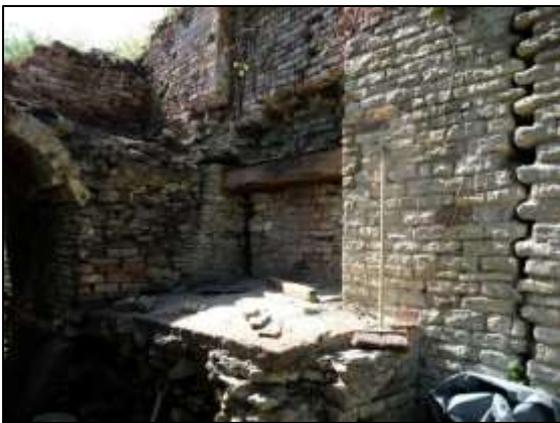
Photo 2 – The supporting beam, made from two old railway sleepers, in place above the Pumping Shaft capping.

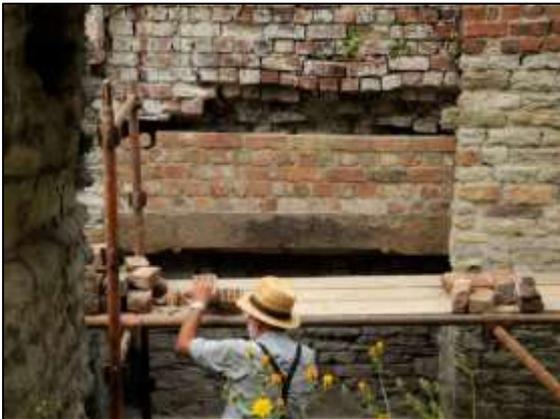
Photo 3 – Partially patched wall above the Pumping Shaft capping on 01 July.

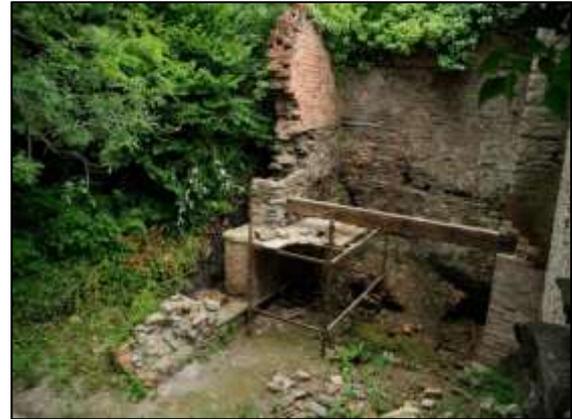
Photo 4 – The extent of unsupported brickwork in the north-east wall of the Old Boiler House can be seen at the middle top of the photo, which was taken in July.

Rebuilding of a major part of the north-east wall of the Old Boiler House is almost finished. This work has two aims: firstly to make a strong area for bracing the wall against the pressure from material in the batch; and secondly to prevent an unsupported part of the wall from collapsing. The

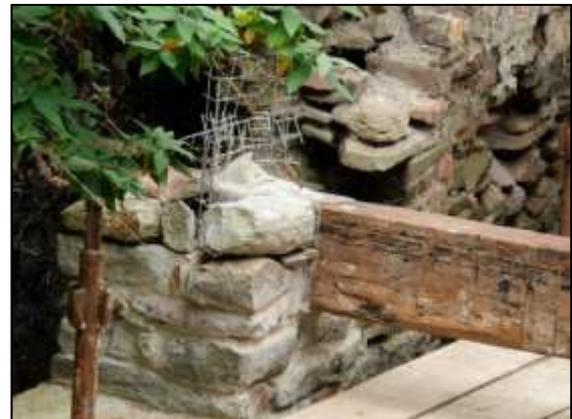
Photo 5 – An early stage in the rebuild of the north-east wall of the Old Boiler House. The bracing beam is in place, and the wire mesh reinforcement for the concrete pad can be seen around its end.

rebuild used stones and bricks recovered when clearing the spoil from the floor of the building. During June and July a stone skin was built up around the batch end of the bracing beam (photos 5 and 6). This was then filled with concrete to provide a strong pad for transmitting the thrust from the material in the batch through the beam to the wall of the heapstead opposite. (The installation of the beam was described in Newsletter N° 7). Photo 4 shows the wall in early July, and the area of unsupported brickwork can be seen at the top of the wall. The wall has now been built up to support this area, which should help to prevent any further collapse. Photo 7 shows the rebuild in progress. The photo on the right shows the wall in mid-August, with just a few finishing touches still to be made to the joint between the masonry and brick sections.

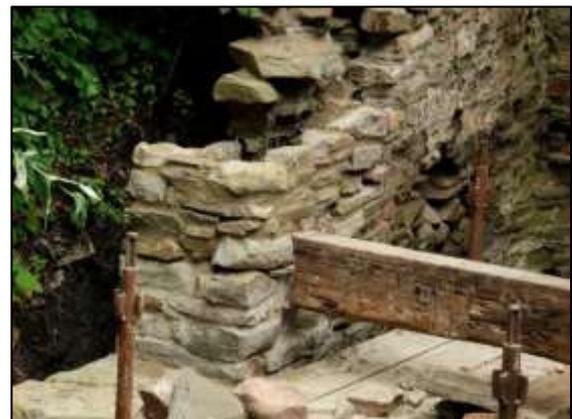
Photo 6 – The stone skin around the end of the bracing beam has been completed, and is ready to be filled with concrete.

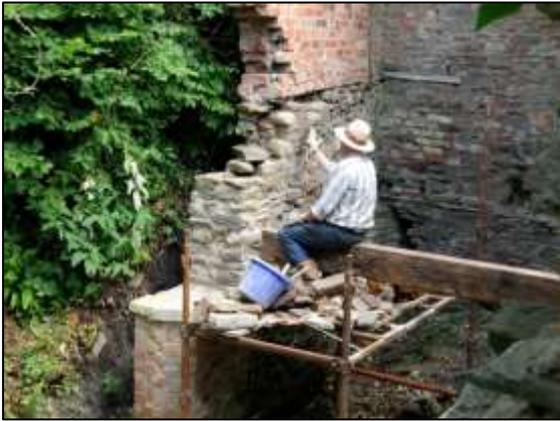
Photo 7 – Repointing some of the partly rebuilt north-east wall of the Old Boiler House.

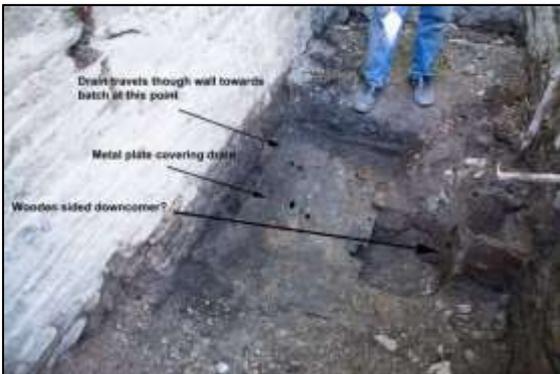
Photo 8 – View of the bottom of the winding drum pit in the Vertical Engine House on 03 June. The spike sticking out of the right hand margin of the photo may have held the wooden sides of the vertical channel in place.

More spoil was removed from the winding drum pit in the Vertical Engine House, clearing the bottom down to a working surface. The bottom layer of spoil was soaked in grease or oil. This has uncovered some stone structures at the bottom that may be drains (see photos 8 and 9). Probing indicated that one of them continued northwards towards the batch, to the left of the photos. On the other side of the pit were the remains of a wooden-framed channel. Scale had been deposited on the inside of the wood, which has rotted away over time (photo 10). The side view of one slab of scale (photo 11) shows how it has been laid down in distinct layers. Among the items found in the spoil were the sole and heel of a hobnailed boot (photo 12) and a piece of ridge tile with the maker's name "Browne & Co Bridgewater" indented into it (photo 13).

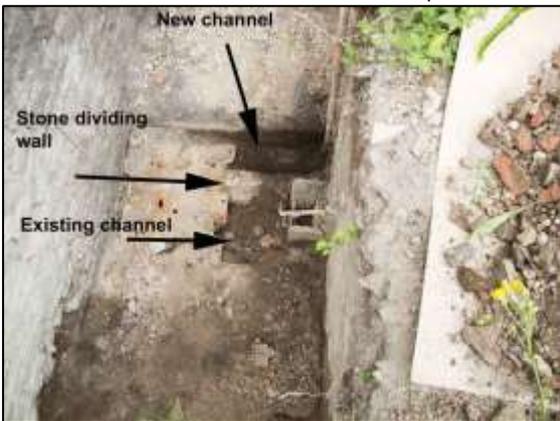
Photo 9 – View of the bottom of the winding drum pit on 01 July after the second channel was uncovered.

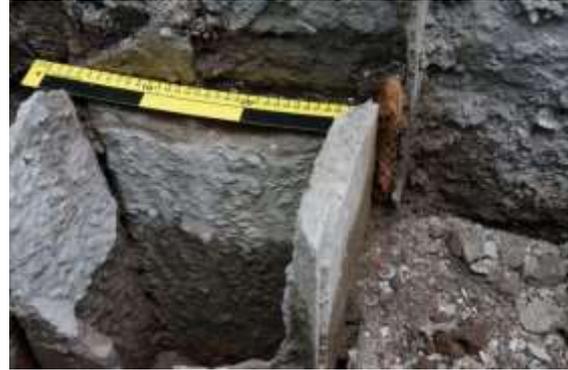
Photo 10 – Close-up of the scale deposited inside the channel in the winding drum pit. Fragments of the wood that formed the channel can be seen on the outside of the slab on the right. (30 cm scale)

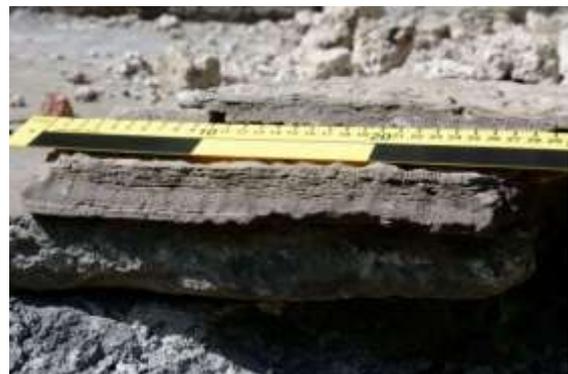
Photo 11 – View of the edge of a slab of scale recovered from the winding drum pit in the Vertical Engine House. This shows that it has been deposited in distinct layers. (30 cm scale)

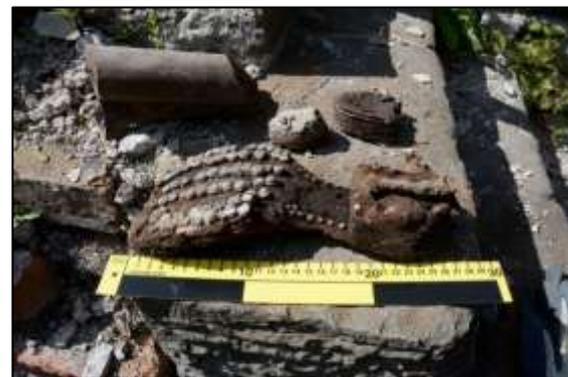
Photo 12 – Sole of hobnailed boot found in spoil in the winding drum pit, Vertical Engine House. (30 cm scale)

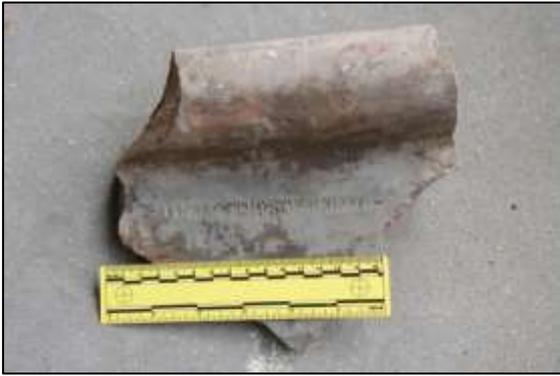
Photo 13 – This 7" long fragment of ridge tile, found in the spoil in the winding drum pit of the Vertical Engine House, has the maker's name "Browne & Co Bridgewater" indented into it. (15 cm scale)

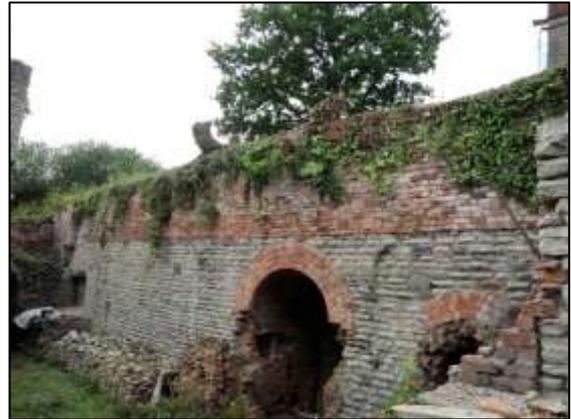
Photo 16 – ... and the same wall in August 2015 after it had been cut back.

Ivy and other vegetation growing around the top of the Old Pit heapstead were given a severe haircut in August. This will help to reduce stresses on the brick top of the heapstead, and has also revealed what may be the original top edge of the structure near the top of the heapstead ramp. A comparison between photos 15 and 16 gives an idea of the amount of ivy and other shrubs that were removed. Both the photos show south-east wall of the heapstead, with the entrance to the alcove appearing on the left hand edge of 15 and the centre of 16.

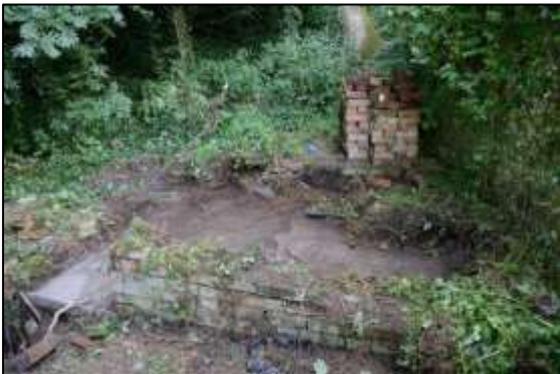
Photo 14 – Concrete floor of Fan Engine House partially cleared of spoil.

Work continued in the Fan Engine House, where more of the concrete floor was uncovered (photo 14).

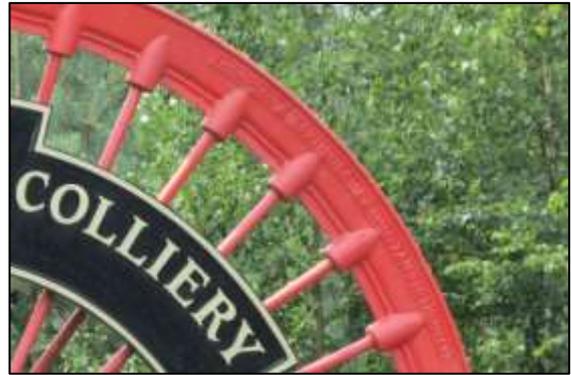
Photo 17 – Half winding wheel at entrance to Thorseby colliery, Nottinghamshire, showing the maker's name. (©T Rendall, July 2015)

comments and photo in Newsletter N° 7) He noticed that one of the half sheaves mounted at the colliery entrance bore the legend 'Thompson & Southwick Ltd Makers Tamworth England' (photo 17) while the other had the intertwined TS logo (photo 18).

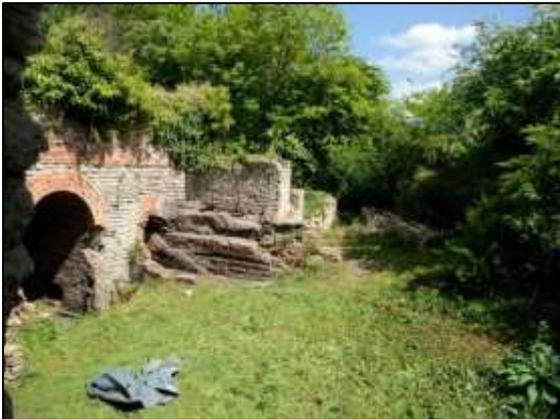
Photo 15 – The South-east wall of the Old Pit heapstead in May 2015, showing the vegetation growing along the top of the heapstead wall ...

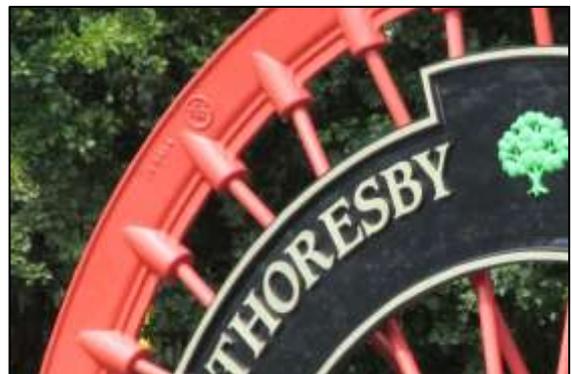
Photo 18 – Half winding wheel at entrance to Thorseby colliery, Nottinghamshire, showing the maker's logo. (©T Rendall, July 2015)
