FRIENDS OF BRANDY BOTTOM COLLIERY, PUCKLECHURCH

Newsletter N° 9, November 2015

Progress: September-November 2015

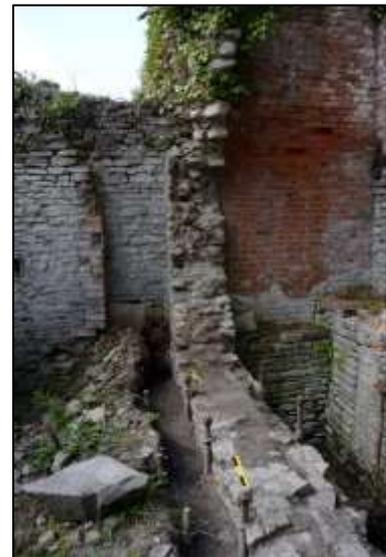
The top of the central wall in the Vertical Engine House was uncovered over August and September (photo right, 30 cm black/yellow scales), allowing an assessment to be made of the work need to cap it and also to build it up its south-western end to support the overhanging section of wall. That section can be seen at the top of the photo. At the same time a narrow trench was dug along the eastern face of the central wall, uncovering a series of bolts for holding down various parts of the engine together with a wooden plate at the south-western end. The plate has been inset into the stonework and fixed with 6 bolts. A close-up of the plate can be seen in photo 3. What it signifies is still to be determined.

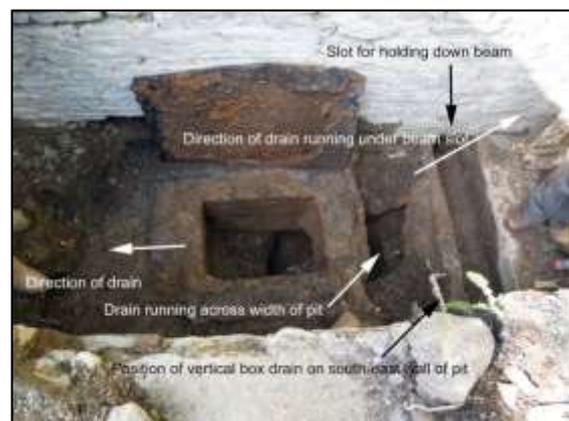
Spoil removal continued in the winding drum pit of the Vertical Engine House. The existence of two stone structures, both originally thought to be drains, was reported in newsletter N° 8. Further spoil removal showed that one is indeed a drain, while a holding down beam was inserted into the other. These structures can be seen in the photo on the right, together with a 27" x 18" manhole that had been covered by the 3/8" thick iron plate that is

resting against the wall at the top of the photo.

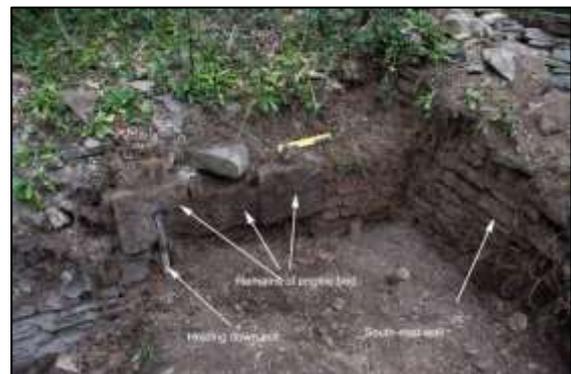
The engine bed was fully uncovered in early November (photo right), lying under the heavy stone slab seen lying behind it against the wall. The slab can be seen in its original position in photo 13, and photo 14 is a close-up of the engine bed. When

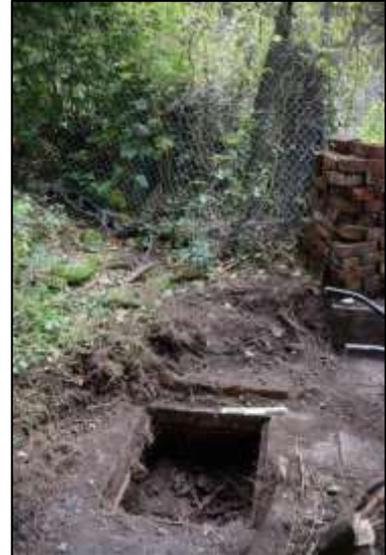
More spoil clearance in the area of the fan engine house in October unearthed a brick-lined pit in the eastern corner of the building (photo right). It is approximately in line with the northern of the fan ducts, and its purpose, as is so often the case at Brandy Bottom, has still to be established. It was closed by a trapdoor, suggesting that frequent access was needed.

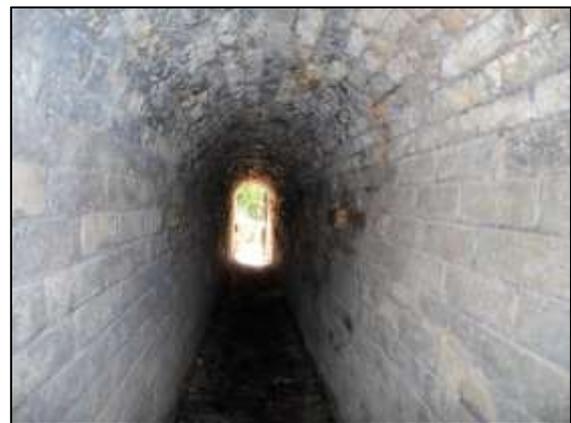
The chimney is a potential target for a lightning strike as it is the highest feature in the surrounding landscape. The ladder has now been earthed, which might help to minimise the damage caused by a strike. Several photos have been taken of the inside of the flue at the base of the chimney, where there are as yet unexplained passages leading into the depths of the heapstead. The photo to the right is a view looking from the chimney end of the flue towards the open air. It shows that the brickwork in that part of the flue is in remarkably good condition.

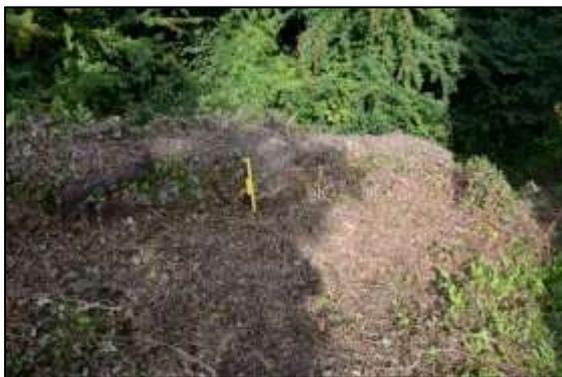
Photo 1 – The original brick raised edge of the Old Pit heapstead from the top of the heapstead. (30 cm scale)

Photographs were been taken of the original edge of the Old Pit heapstead (photos 1-2). As mentioned in the previous newsletter, N° 8, this had been uncovered during vegetation clearance. The brick edge is about 30 cm high, and is currently unsupported as the stone face of the heapstead below has crumbled away. Rebuilding the wall is one of a number of items on the contract of work that is currently being drawn up.

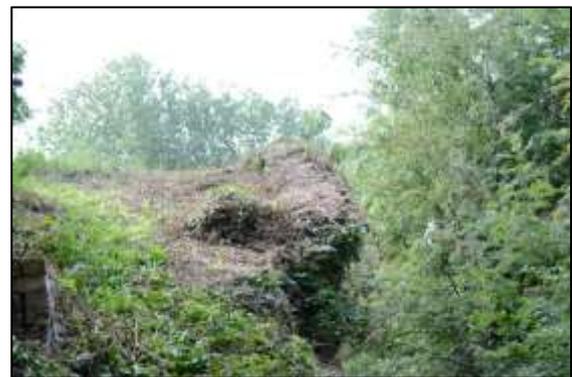
Photo 2 – The original edge of the Old Pit heapstead can be seen in the centre of the photo. The apparent overhang has been caused by the face of the heapstead wall below crumbling away.

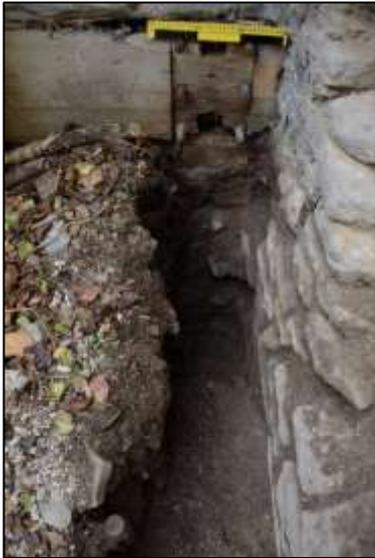
Photo 3 – Close-up of wooden plate (below 30 cm yellow/black scale) inset into the stonework of the south-western wall of the Vertical Engine House and fixed with 6 bolts.

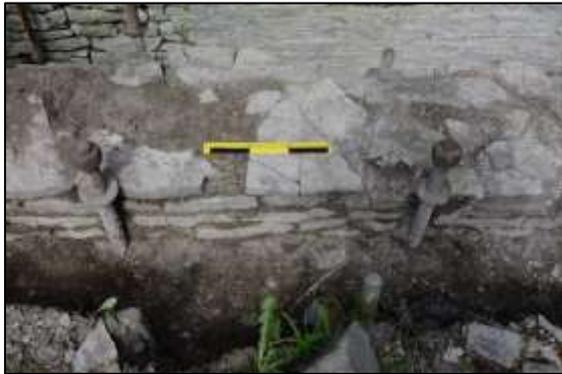
Photo 4 – Close-up of part of the central wall of the Vertical Engine House, with the winding drum pit in the background. (30 cm scale)

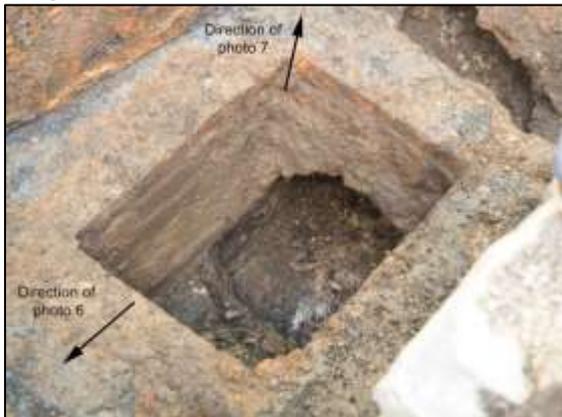
Photo 5 – Close-up of the manhole in the base of the winding drum pit, Vertical Engine House, showing the arched construction of the top of the drain.

The arched structure of the drain can be seen more clearly in photo 5, with views in both directions shown in photos 6 and 7. The drain in photo 6 goes in the direction of the pit in the nearby alcove in the heapstead, while the one in photo 7 disappears under the batch and heads in the direction of the Old Boiler House. So far it has not been possible to establish where the drains came from or where they were going to. They are too small for someone to wriggle down, and 'selfie sticks' have a limited range. (Yes a 5 feet long one has been tried, with the small camera swivelled 180° and set to take flash photos at 10 second intervals.) There is a possibility that the drain carried the water away from the pumping shaft, but to prove that requires the drain to be traced back to the shaft - What is needed is one of those cameras on tracks that water companies use ... which for us is probably the proverbial pipe dream.

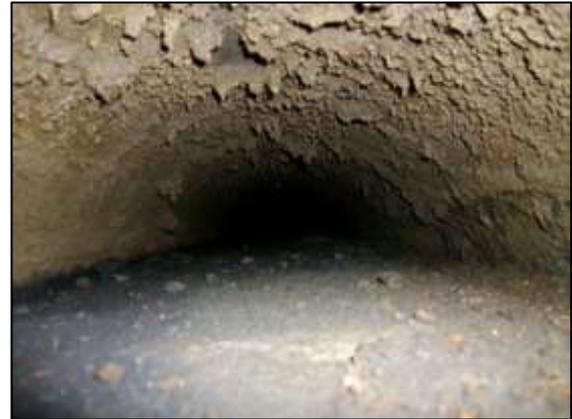
Photo 6 – View southwards along drain running under winding drum pit, Vertical Engine House. (© K Kemp)

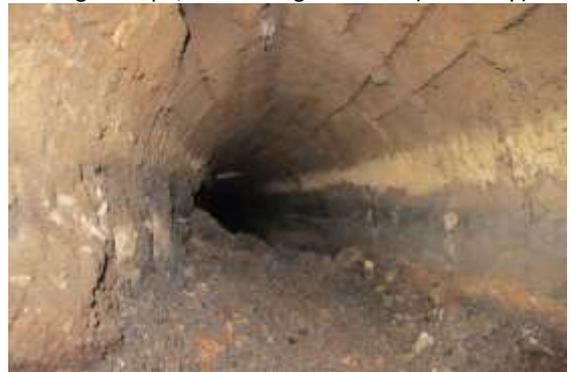
Photo 7 – View northwards along drain running from winding drum pit towards Old Boiler House. (© S Grudgings)

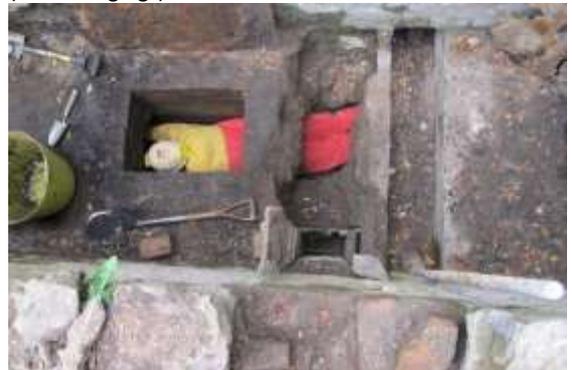
Photo 8 – Spoil being cleared from the drain under the winding drum pit. (© S Grudgings)

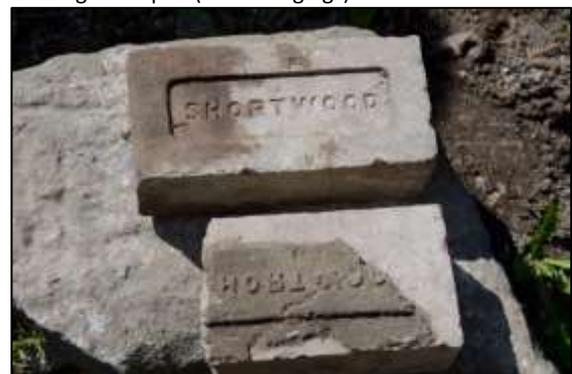
Photo 9 – Shortwood brick (top) found beside central wall of the Vertical Engine House, with the reversed

image of the frog in the mortar attached to the brick below. The lower brick also has 'Shortwood' imprinted into its frog.

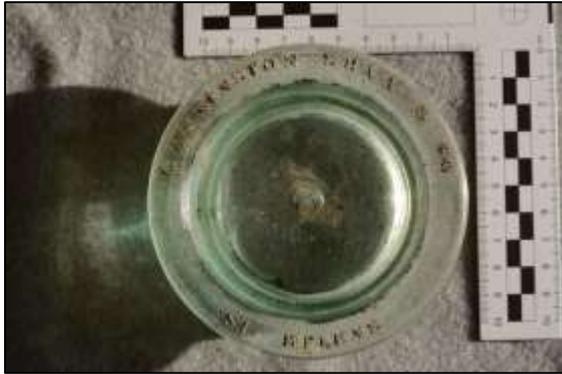
Photo 10 – 4½” dia. glass stopper bearing the inscription 'Cannington Shaw & Co St Helens' around the rim. (10 cm x 10 cm scale)

One artefact uncovered in this area was the 4½" dia. glass stopper seen in photo 10, which bears the legend 'Cannington Shaw & Co St Helens' around the rim. Research by a South Gloucestershire Mines Research Group (SGMRG) member has established that the company operated between 1875 and 1913, and that the style of lettering on the stopper was in use between 1875 and 1892. Cannington Shaw was one of 6 companies that amalgamated to form the United Glass Bottle Manufacturing Co.

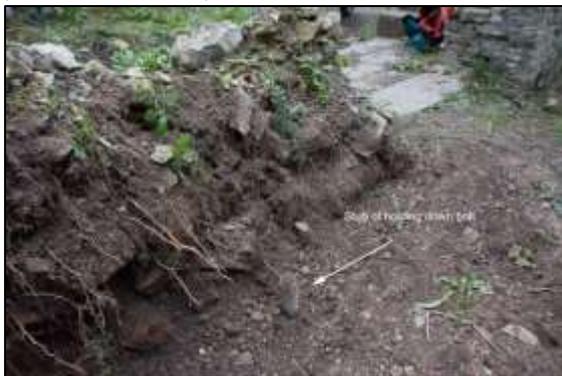
Photo 11 – Stub of holding down bolt next to the south-east wall of the Vertical Engine House, with the entrance door at the top right of the photo.

One of the items on the masonry contract is the strengthening of the walls of the Vertical Engine House, rebuilding where necessary and also capping the walls to protect the walls from rain. A start was made in October on clearing spoil from the inside of the south-east wall, starting at the doorway and working northwards. This first uncovered a lone stub of a holding down bolt near the entrance, which can be seen in photo 11. This bolt is in line with a row of others to its north. Then several cream-coloured bricks were found with fragments of the word 'Bovey', which may have been part of the fireplace. This is an area where a 1982 photo showed there to have been a fireplace. Photo 12 shows the most complete brick, with just the final Y missing. These bricks may well have come from the brickworks at Bovey Tracey. If so, why was the local supply of bricks ignored? As the spoil clearance continued northwards, the remains of an elevated engine bed was uncovered, and the photo above right shows progress at the end of October. The size of the bed is indicated by the 30 cm yellow/black scale.

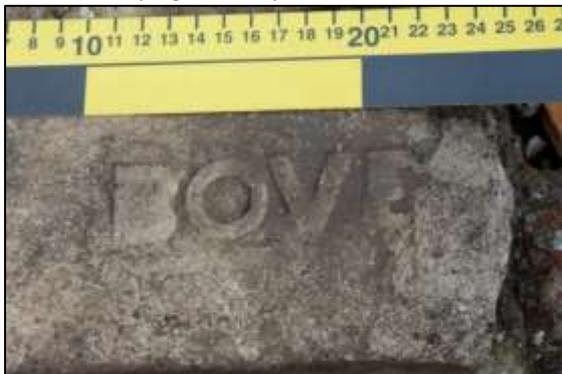
Photo 12 – Brick with most of the legend 'Bovey' visible on the face, found near the entrance to the Vertical Engine House. (30 cm scale)

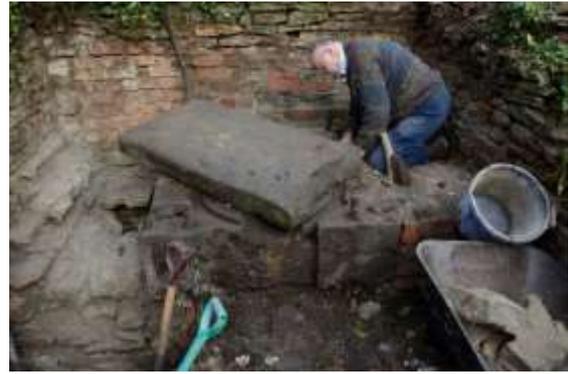
Photo 13 – The engine bed in the Vertical Engine House before the stone slab covering it was lifted.

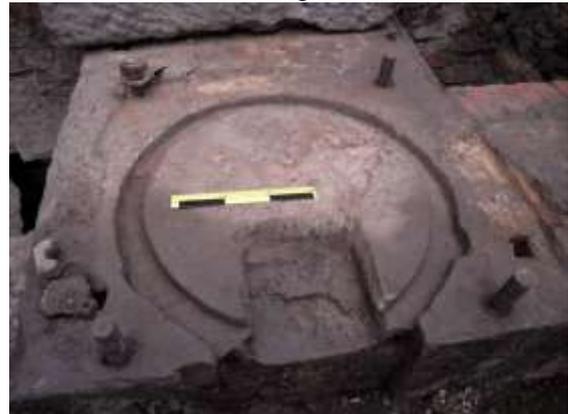
Photo 14 – Close-up of the engine bed found in early November in the north-east corner of the Vertical Engine House. (30 cm scale)

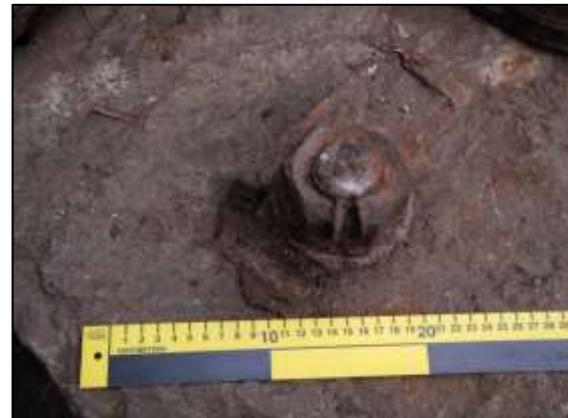
Photo 15 – This nut, one of 4 that held a cylinder down in the Vertical Engine House, has been partly cut in two with a cold chisel. A scrap of the cylinder casing, left attached to the bolt, can be seen in to the left and top of the bolt. (30 cm scale)

the scrap metal workers came to strip out the cylinder, they were obviously unable to undo one of the nuts. Plan B appears to have been an attempt to split the nut in two with a cold chisel (photo 15), but that did not succeed. Instead they must have gone for Plan C and broken the cylinder casing apart, leaving a fragment still attached to the bolt. Finding the engine bed was totally unexpected. As the 1900 sales catalogue mentioned two cylinders, the next item on the agenda is to find where the second was located. As part of this exercise, the positions of the numerous holding down bolts, including several long ones that are outside the north-east and south-west walls, will have to be plotted.

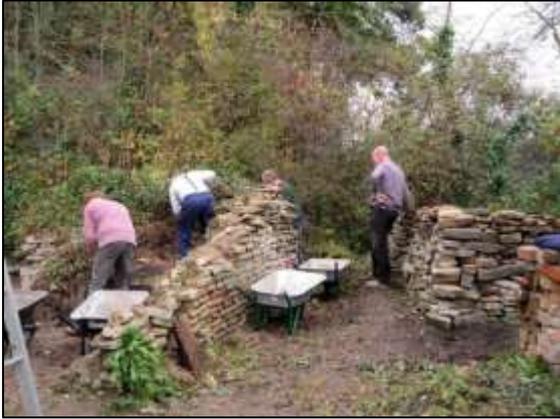
Photo 16 – Clearance work on both the inside and outside the Vertical Engine House.

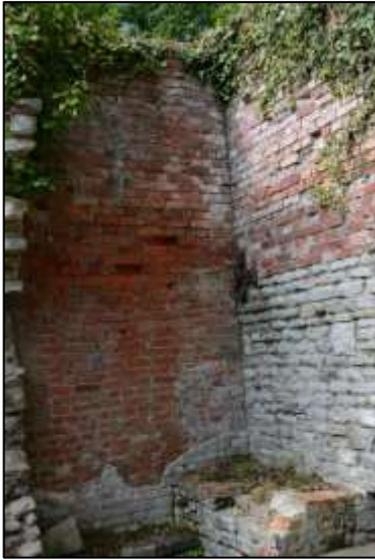
Photo 17 – Section of the south-west wall above the winding drum pit in the Vertical Engine House. The area where there is a change in the bond and of the type of bricks used is in the middle, and can be seen in close-up below.

There have been many discussions during work parties about the various phases of building at the Old Pit heapstead. One current area of interest is in the Vertical Engine House, where there are changes in both brick size and bond pattern in the heapstead wall above the south-western end of the winding drum pit. This wall would have been underneath the path of the winding ropes between the drum and the headgear. Photo 17 is a general view of the wall, while photo 18 is a close-up of the area of interest. Part of the adjacent, north-west, wall of the Vertical Engine House can be seen in photo 19. The wall follows the usual heapstead pattern of brick over stone, but a thin course of stone can be seen running between two brick courses in the middle of the picture.

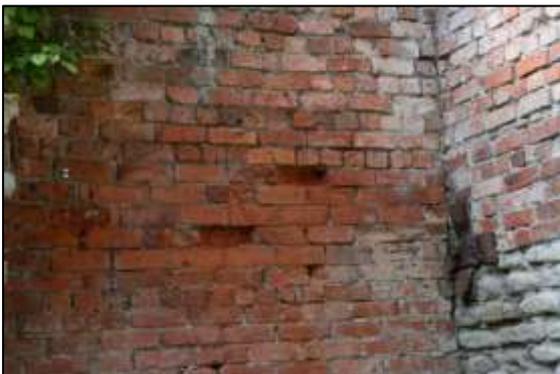
Photo 18 – Close-up of the centre of the south-west wall of the Vertical Engine House, showing the area above the winding drum pit where the bond and type of bricks change.

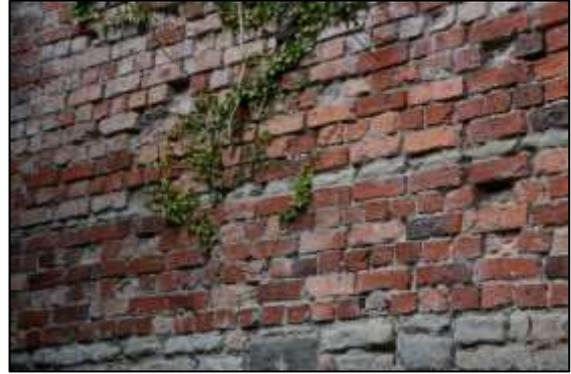
Photo 19 – Close-up of the north-west wall of the Vertical Engine House. The bottom of the wall is made of stone, with brick above. Note the single course of thin stone running across the middle of the photo.
